**Closure Unit 4 Work Completion Report, Revision 1**  
Three Kids Mine  
Henderson, Nevada

Project No. 23-01-200

Re: **Closure Unit 4 Work Completion Report, Revision 1**  
Three Kids Mine, Henderson, Nevada

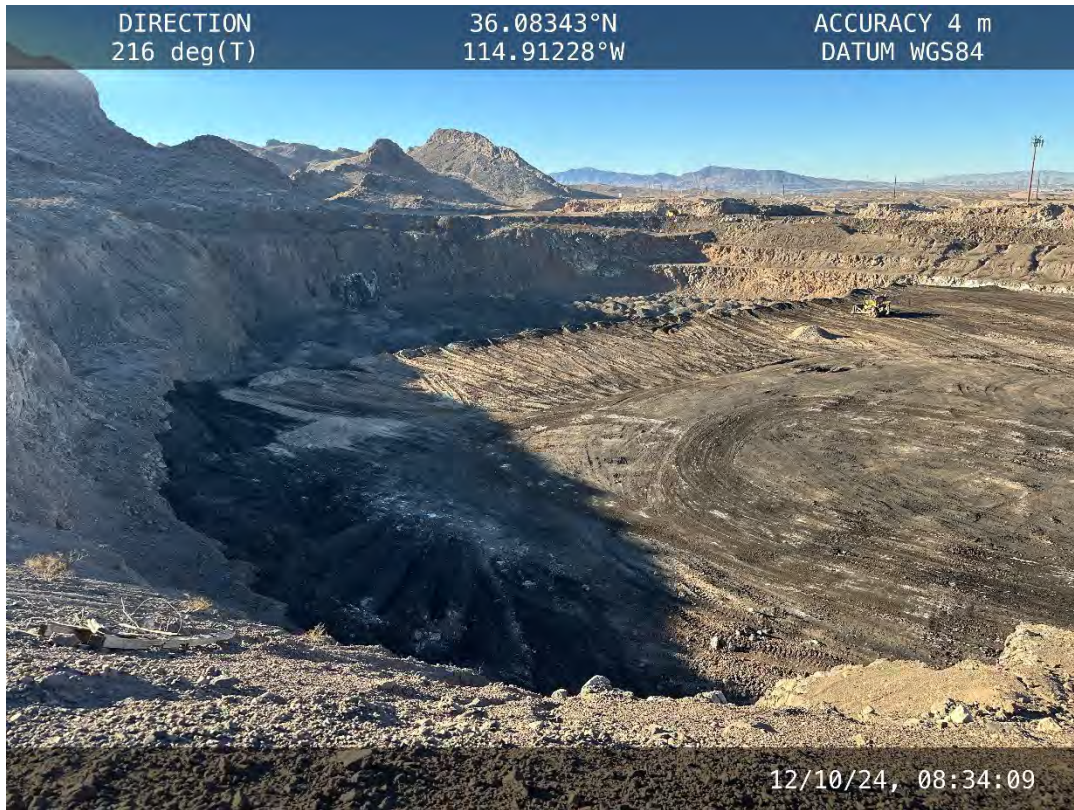
Hydro Pit Backfill – December 10, 2024

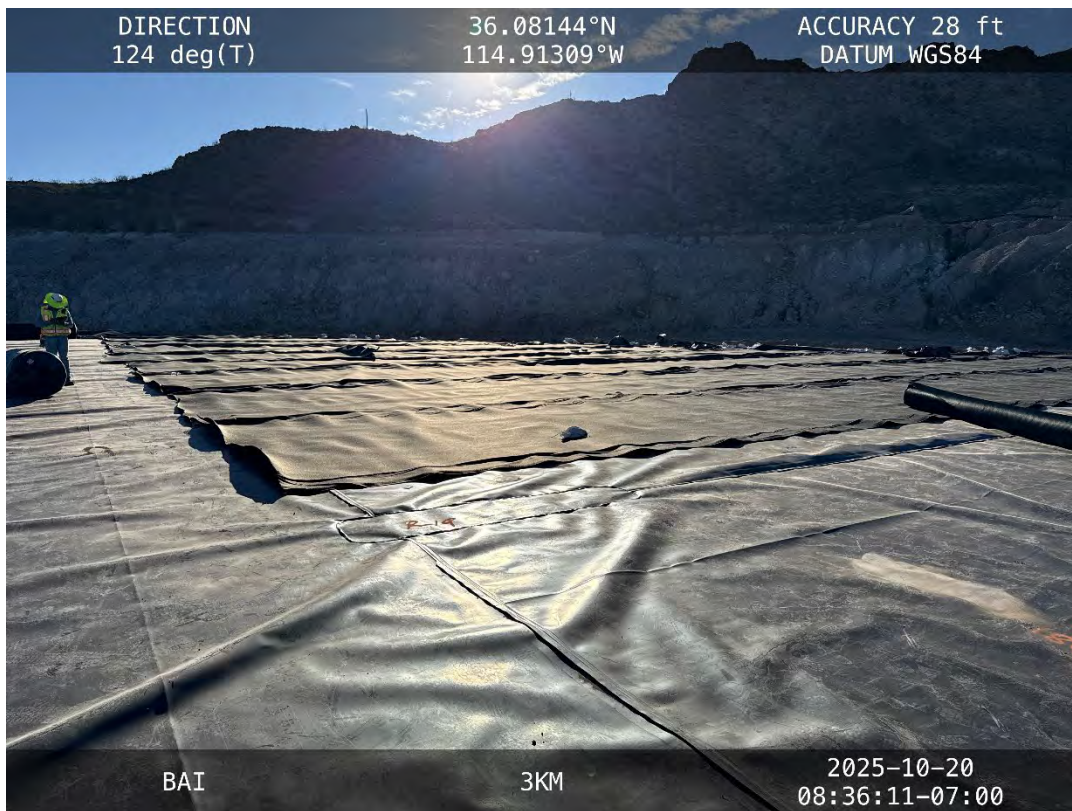
Drainage net and geotextile fabric installation over Hydro Pit liner – October 20, 2025

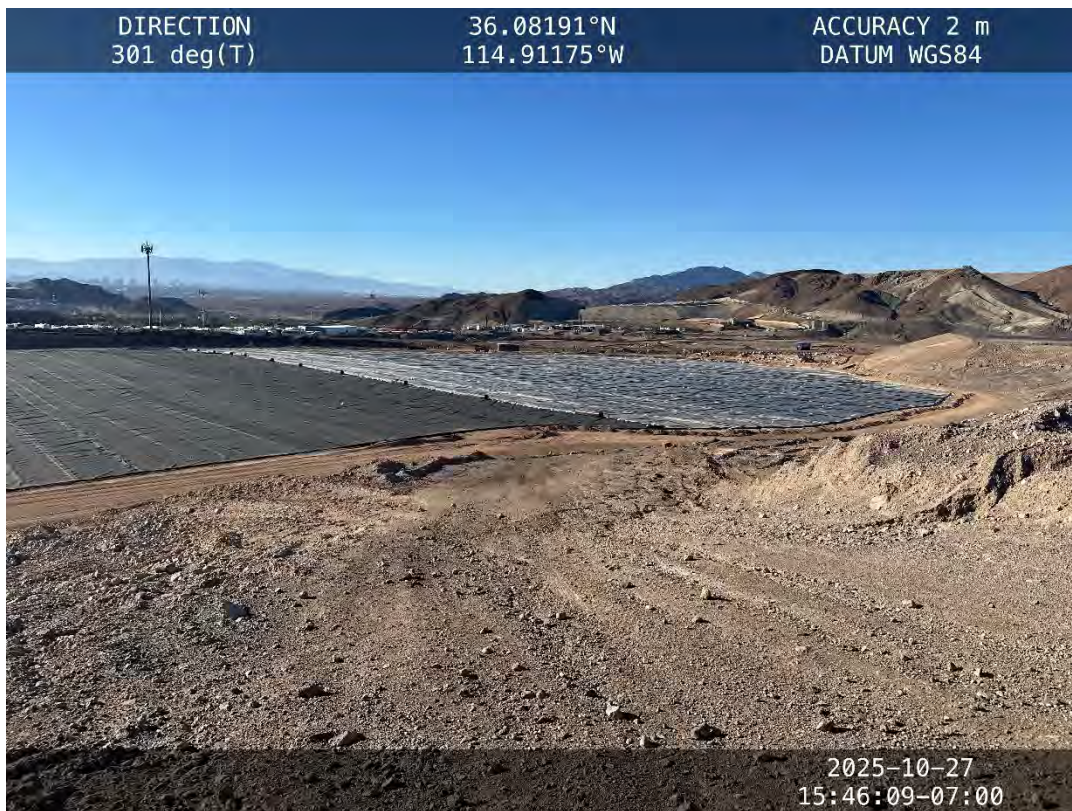
Hydro Pit liner installation – October 27, 2025

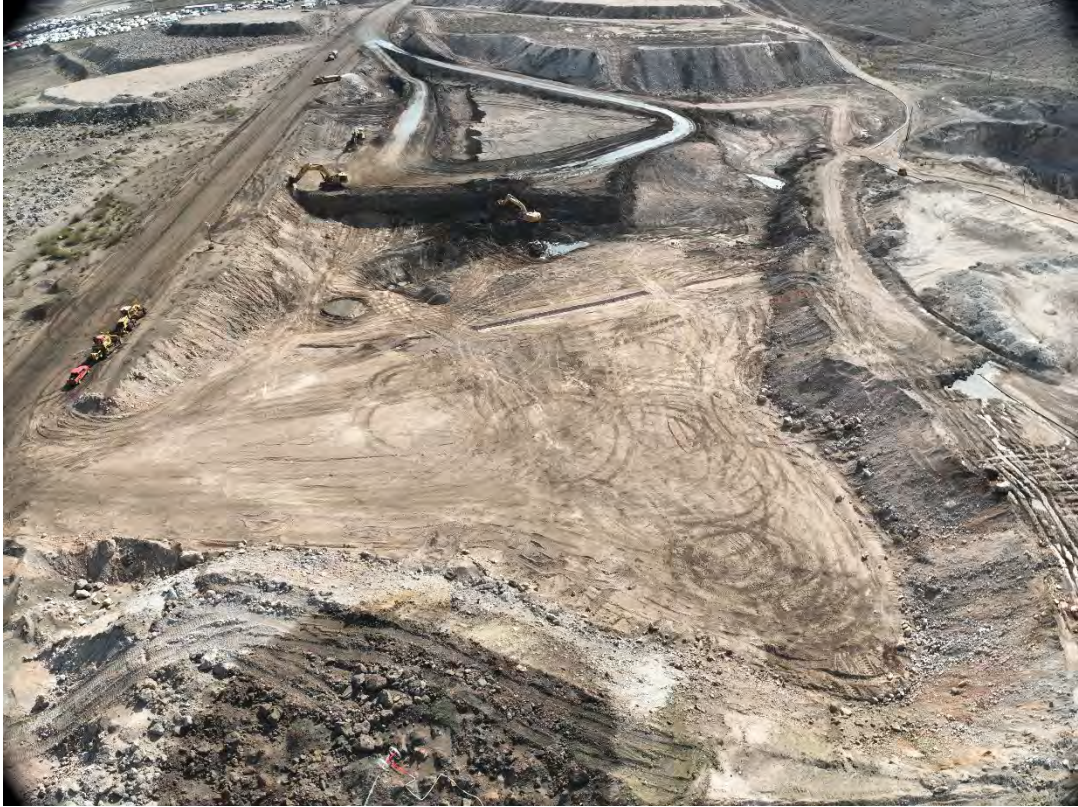
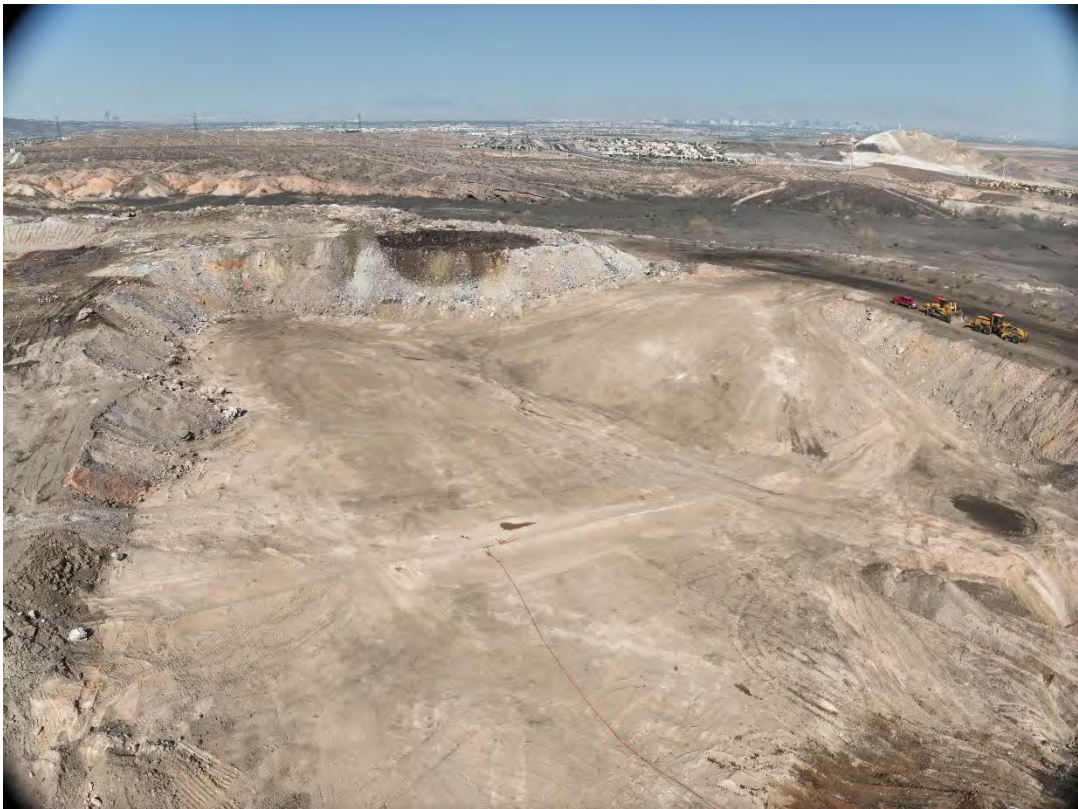
An initial CEM clearance walk for Tailings Pond 3 West was completed on July 17, 2024. Control points were placed and surveyed by WMK the same day, and a VT drone collected elevation data of the maximum surface of excavation the following day, July 18, 2024. WMK used the surveyed control points to verify the drone-collected elevation data. Additional gray-stained waste rock material was removed from the edges of Tailings Pond 3 West, and a final CEM clearance walk was completed on July 22, 2024. Drone photographs were taken on July 25, 2024. Figure 4 depicts the elevation of the excavation surface of Tailings Pond 3 West. Appendix B includes photographs of Tailings Pond 3 as of July 25, 2024.

**Tailings Pond 3 West – July 25, 2024**

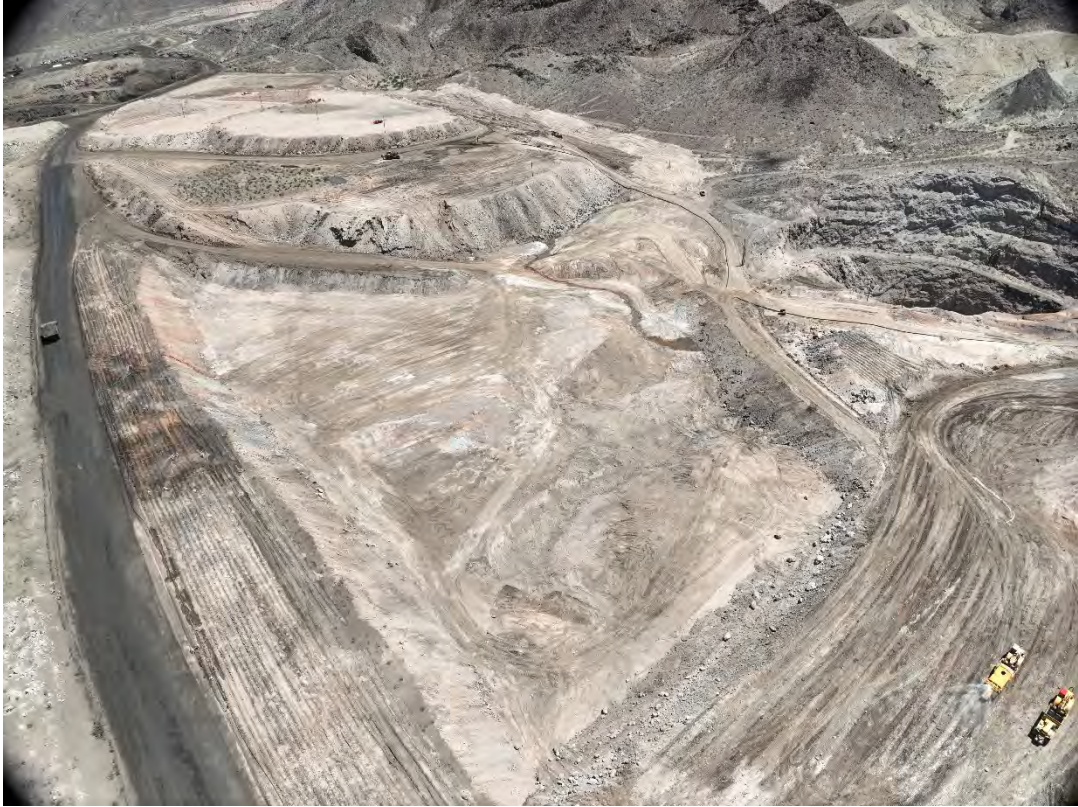
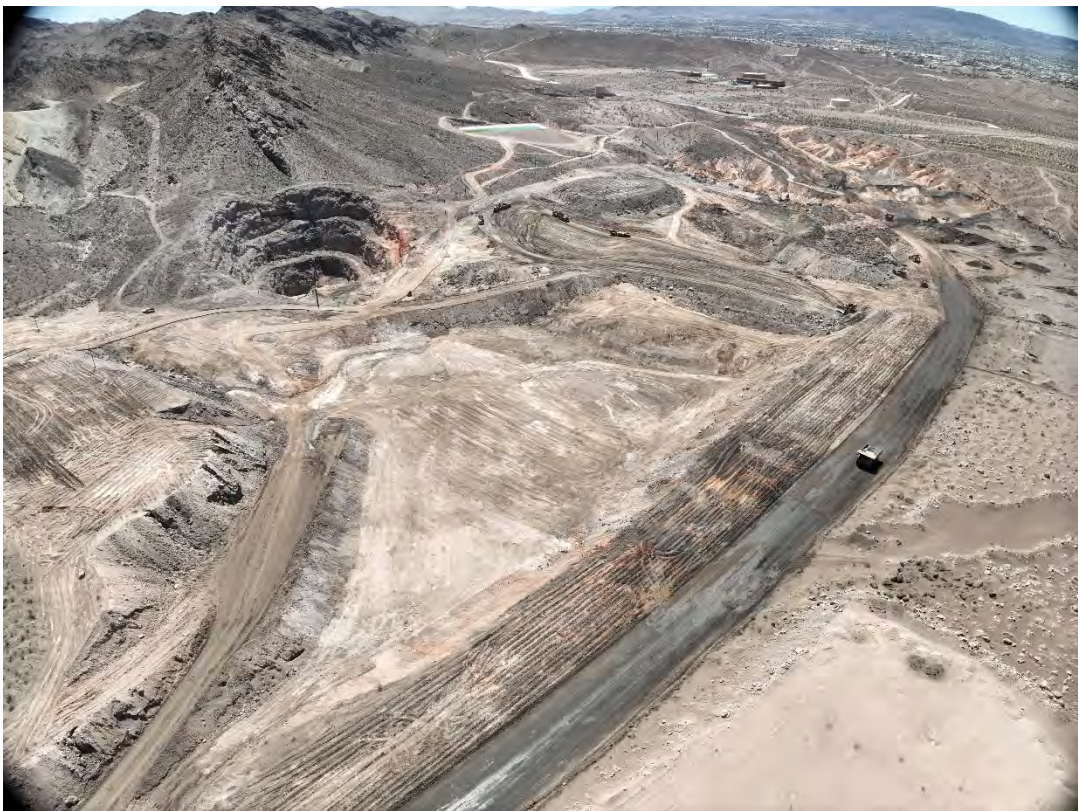
**Tailings Pond 3 East – August 16, 2024**

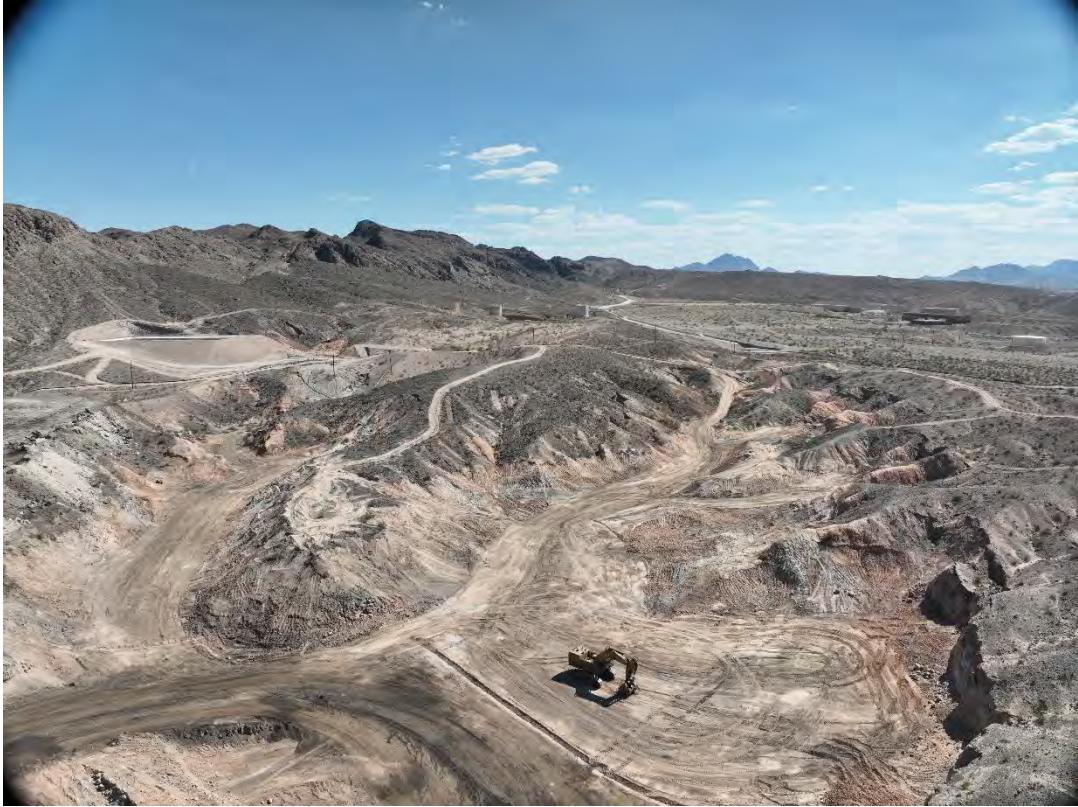
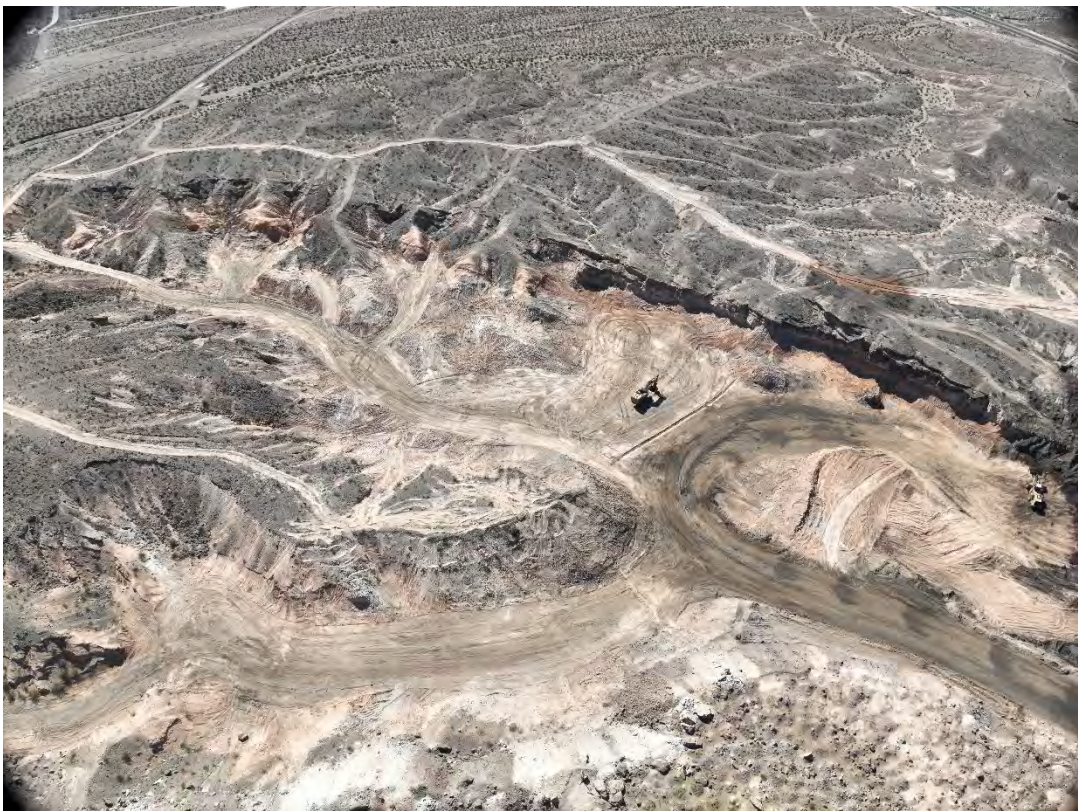
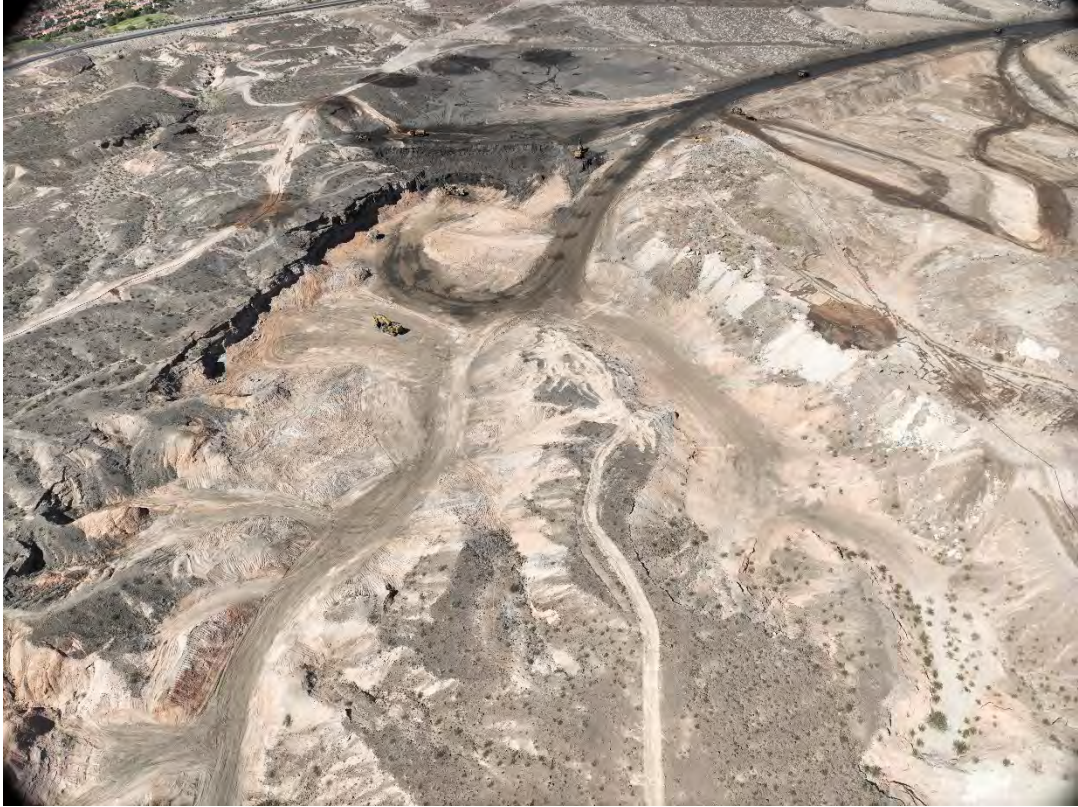
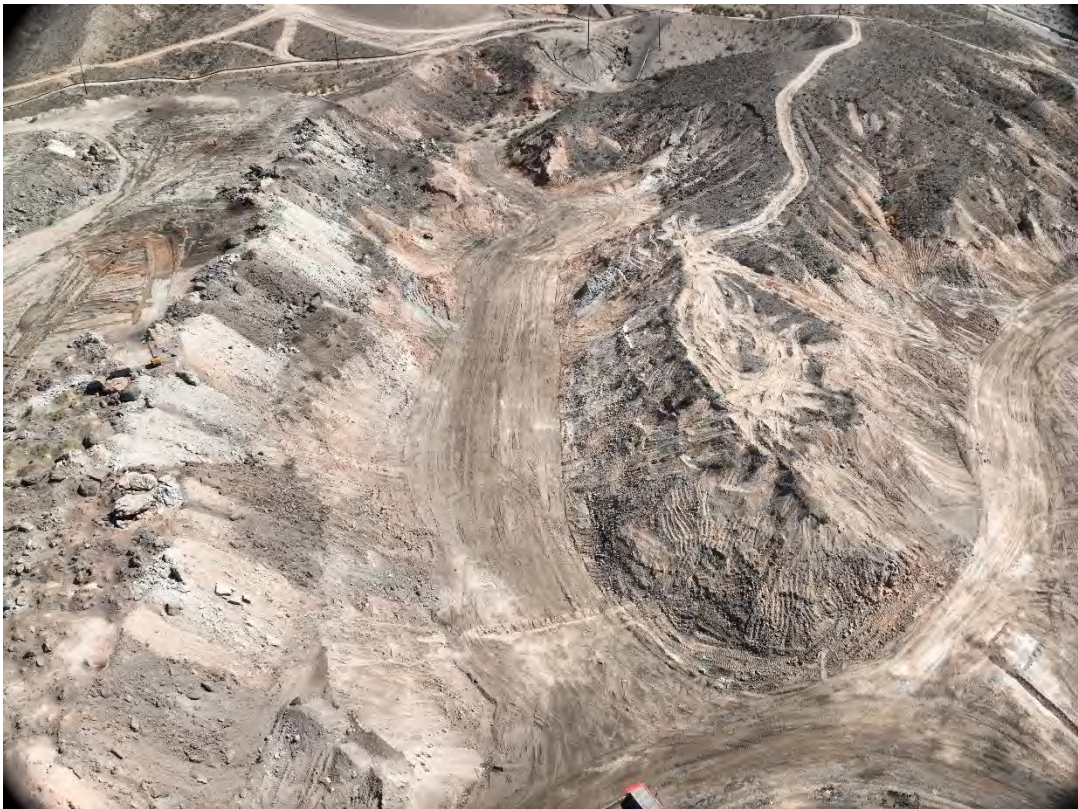
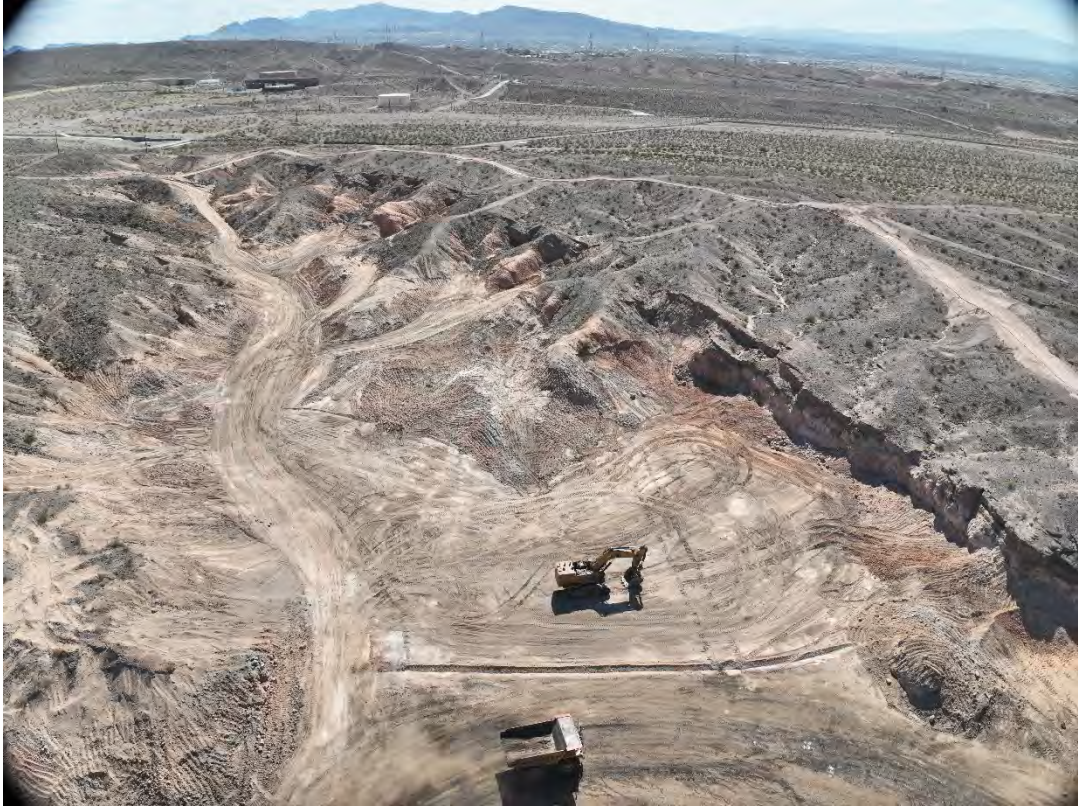
**Tailings Pond 2 South – September 4, 2024**

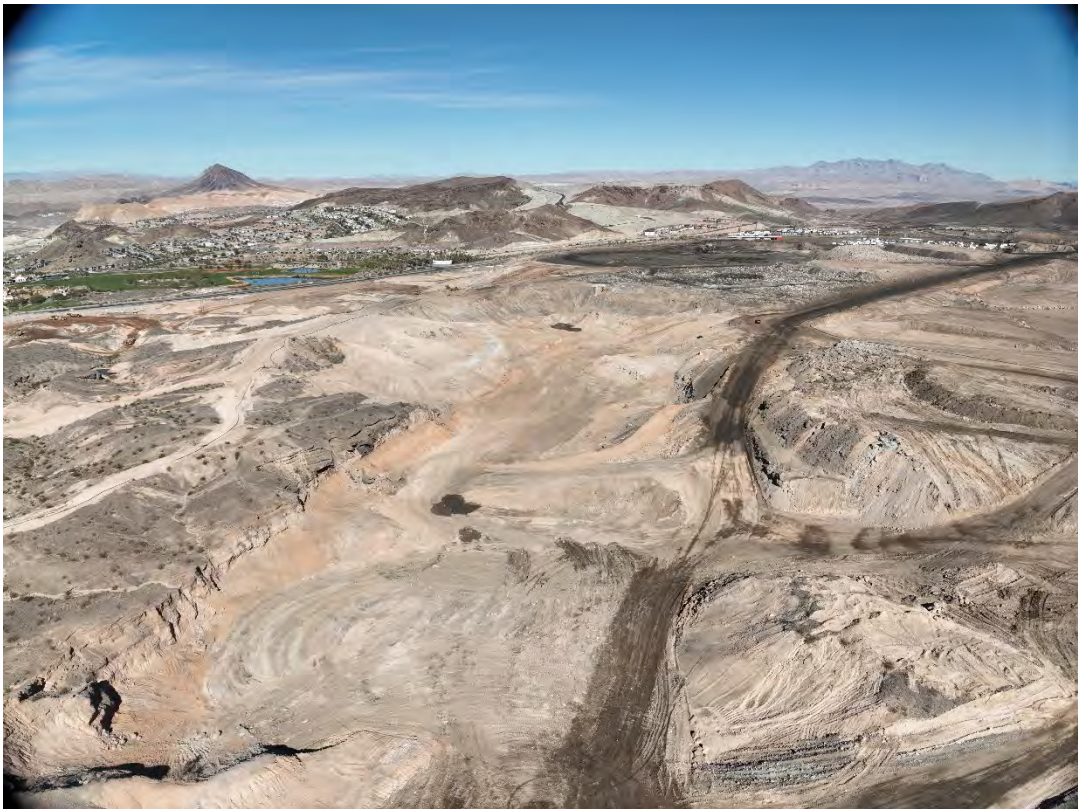
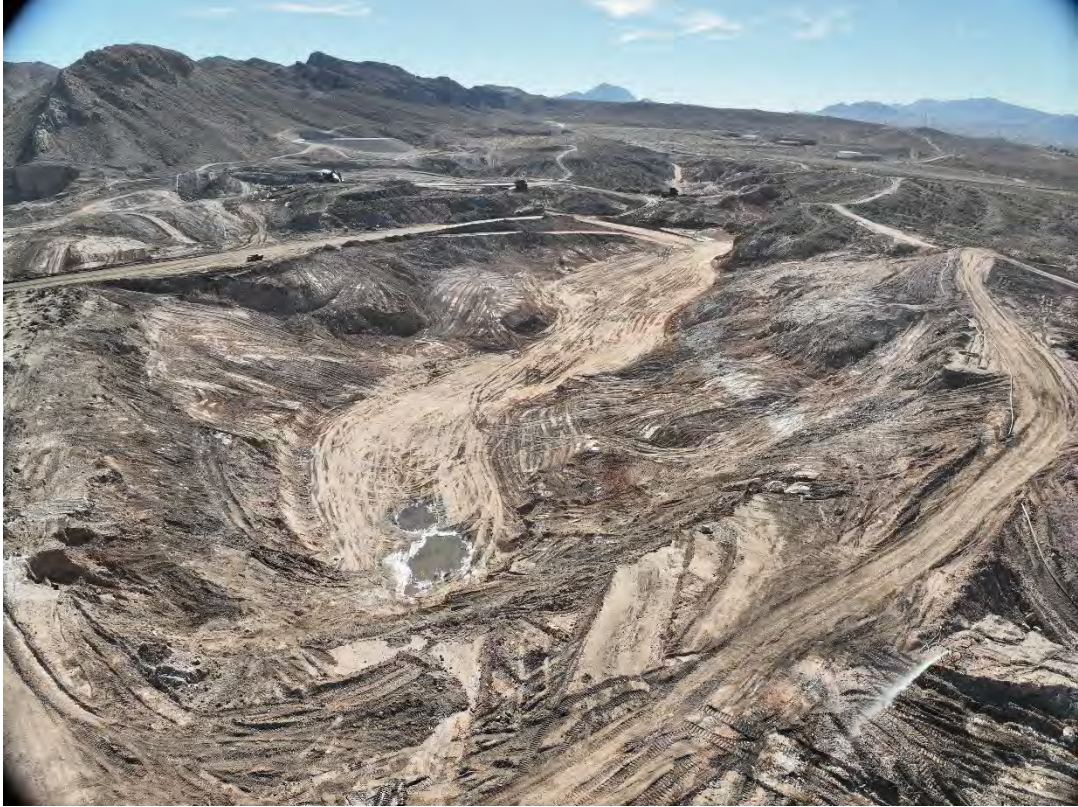
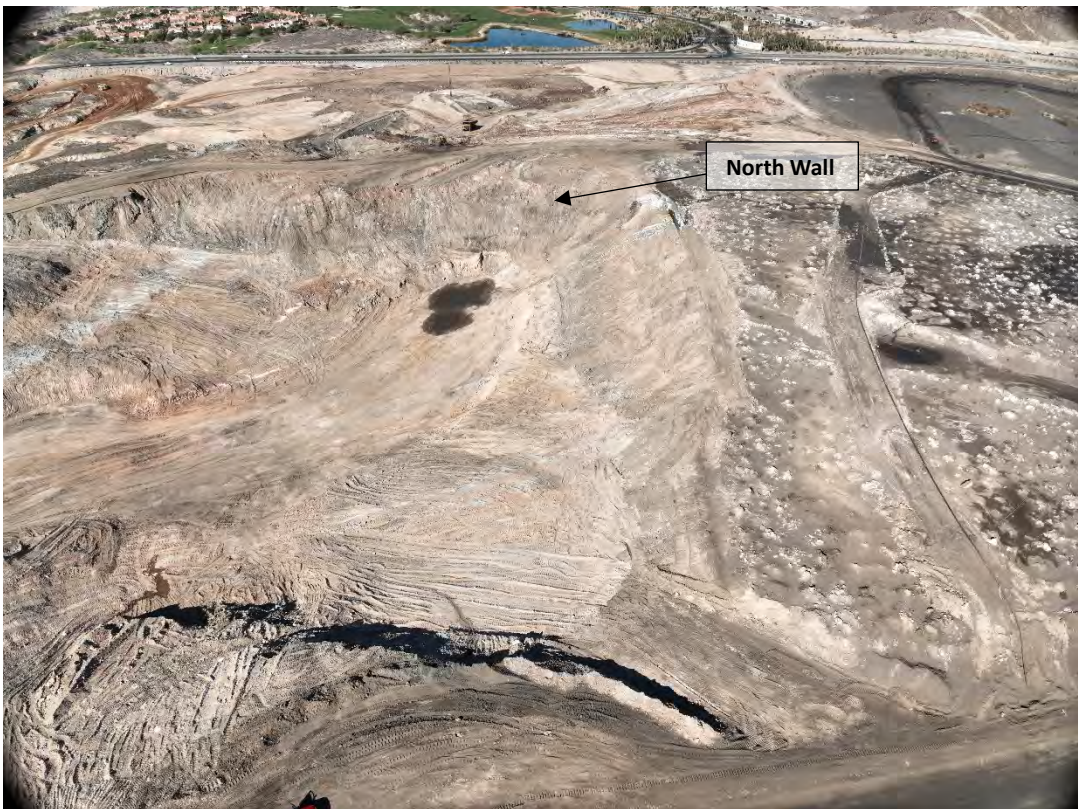
**Tailings Pond 2 North – November 18, 2024**

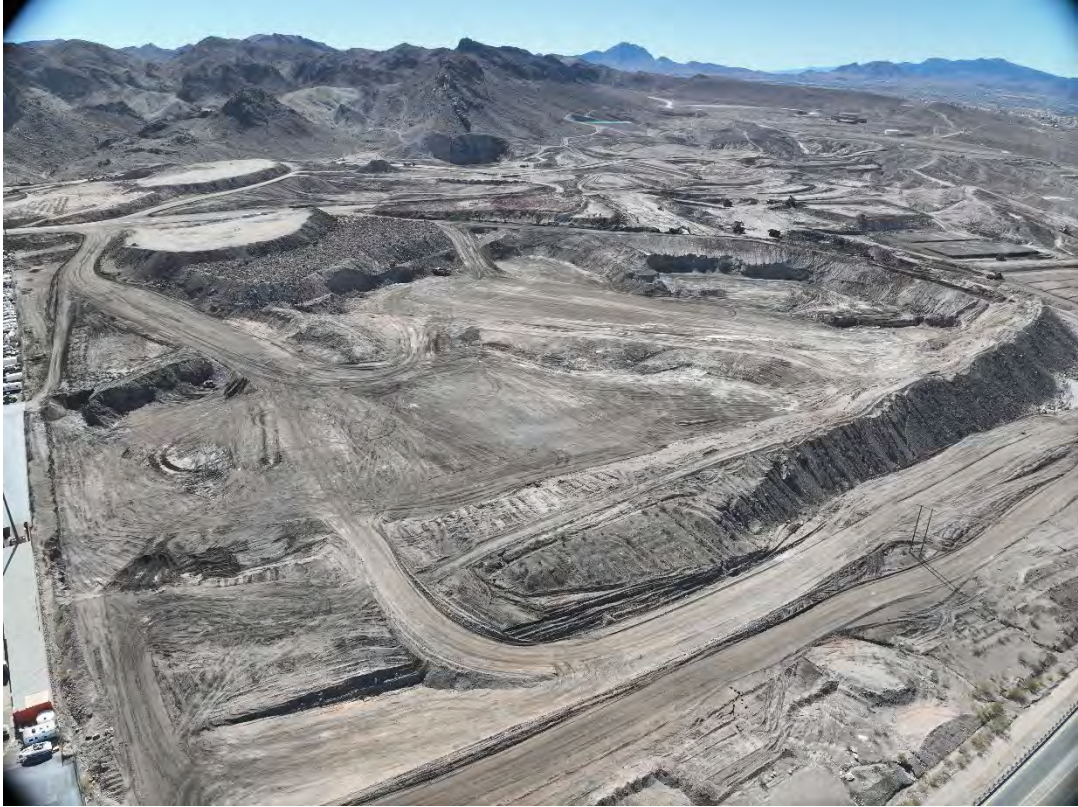
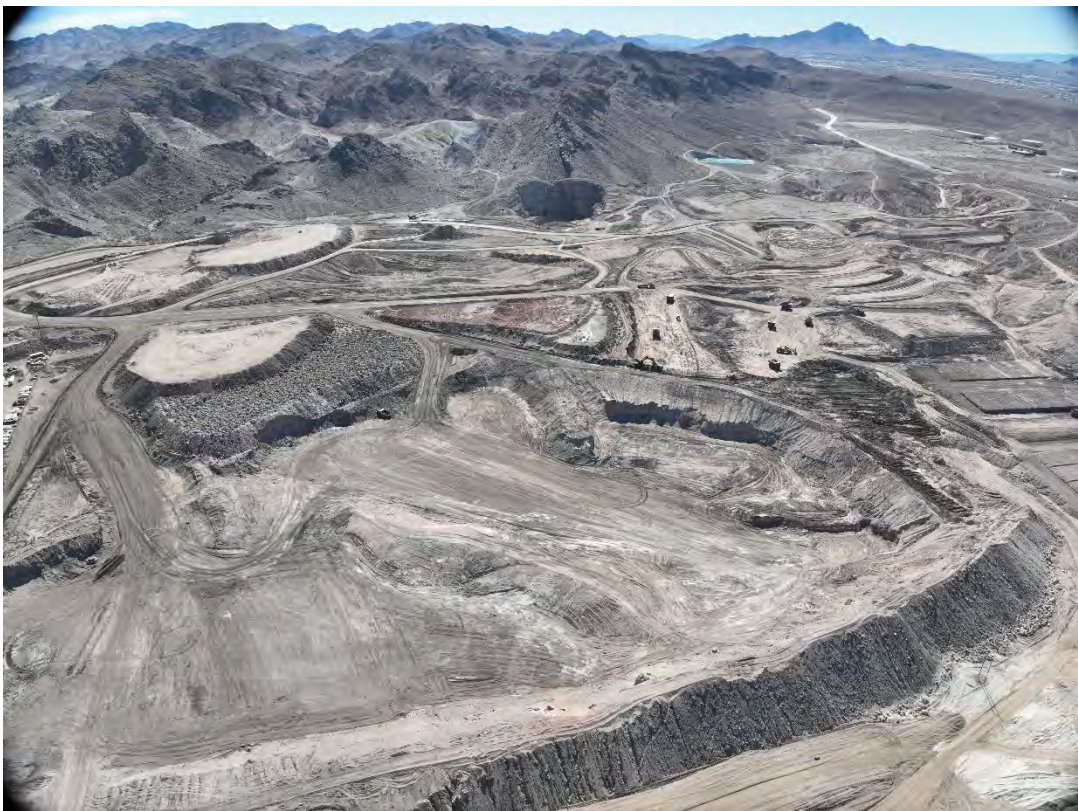
**Tailings Pond 1 West – February 21, 2025**

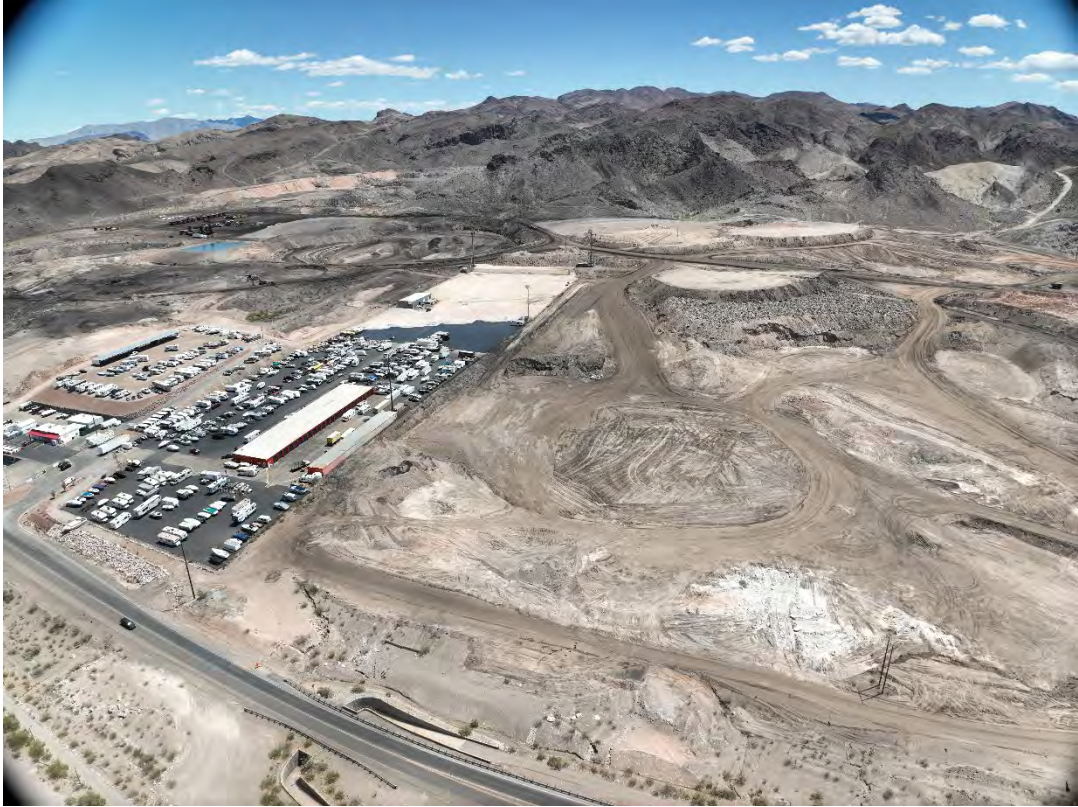
**Tailings Pond 1 East – April 28, 2025**

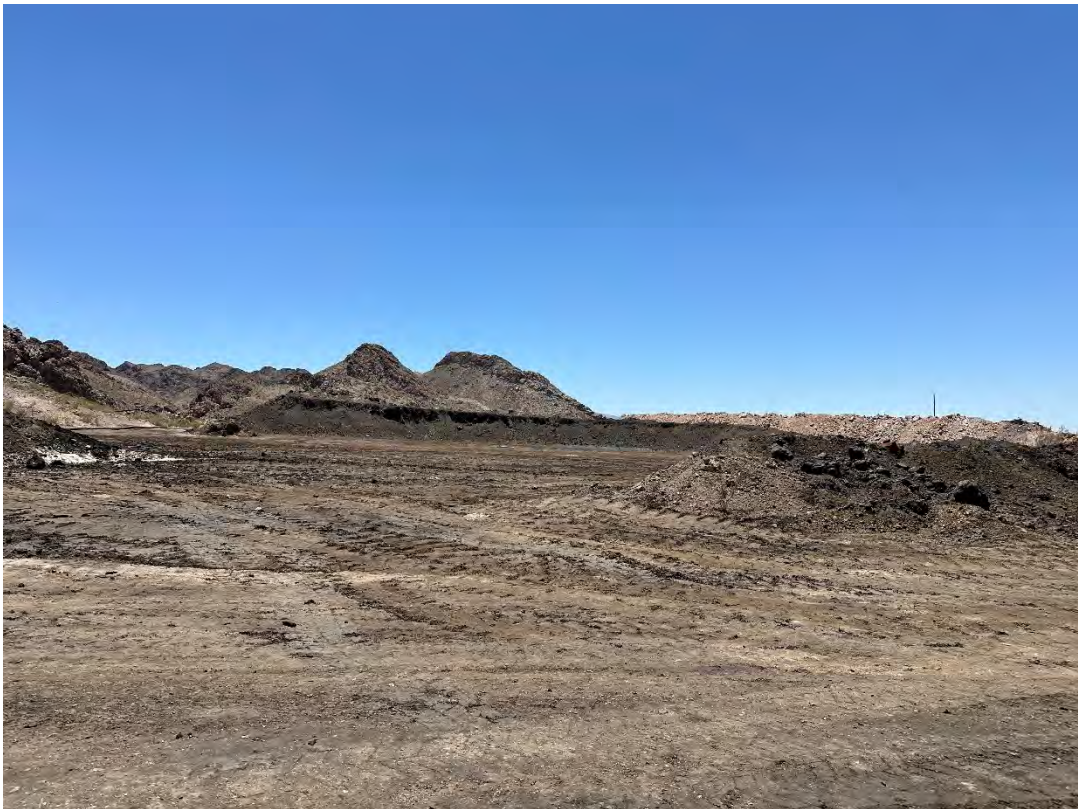
**Tailings Stockpile area – June 17, 2024**

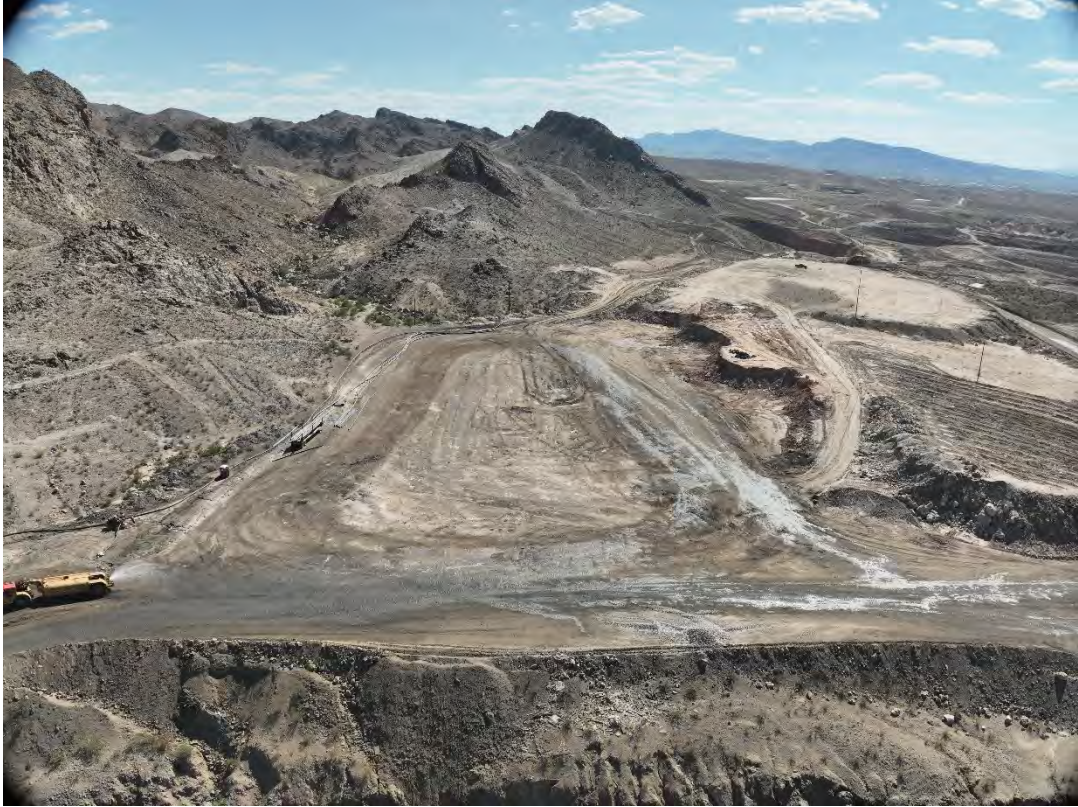
**Tailings Stockpile area – September 4, 2025**

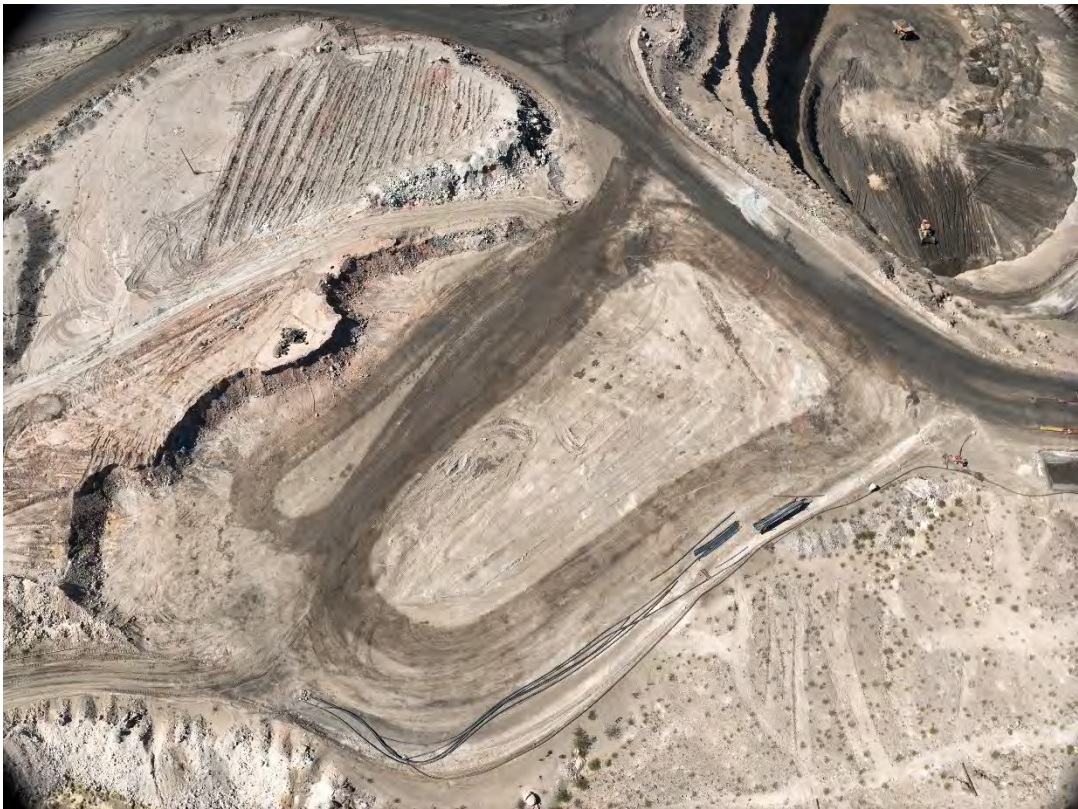
**Tailings Stockpile area – September 4, 2025**

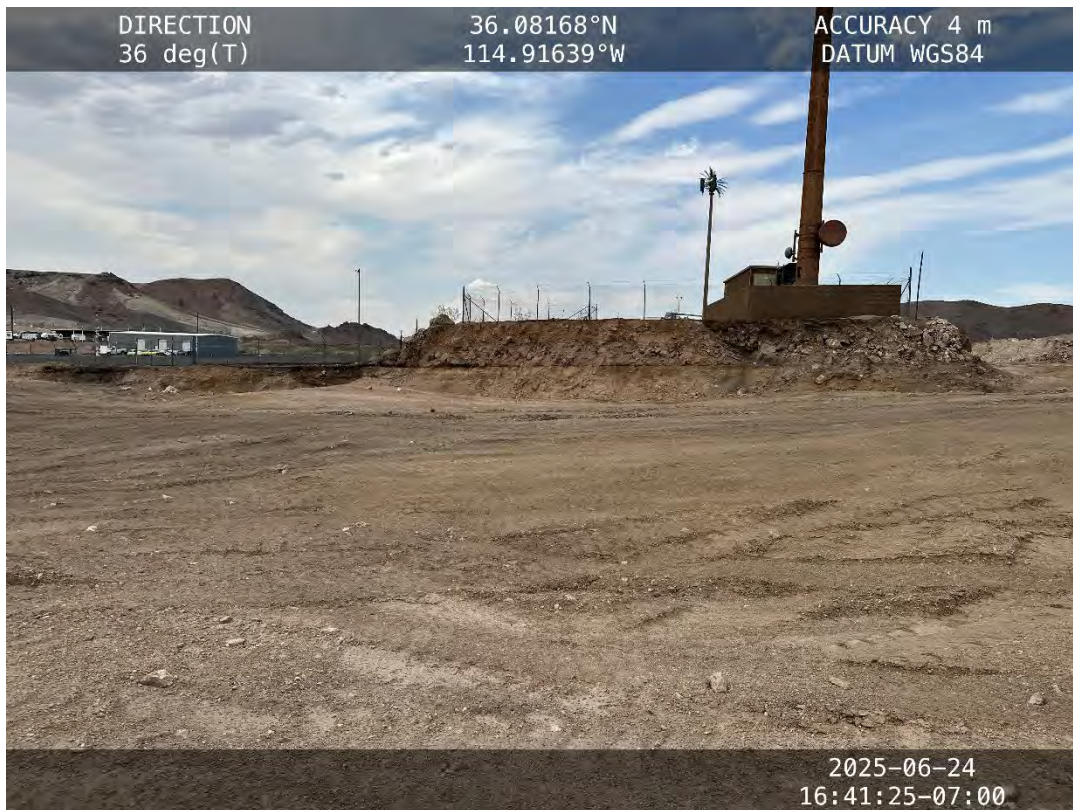
Cleared area from tailings seam southeast of Tailings Pond 1 – June 24, 2025

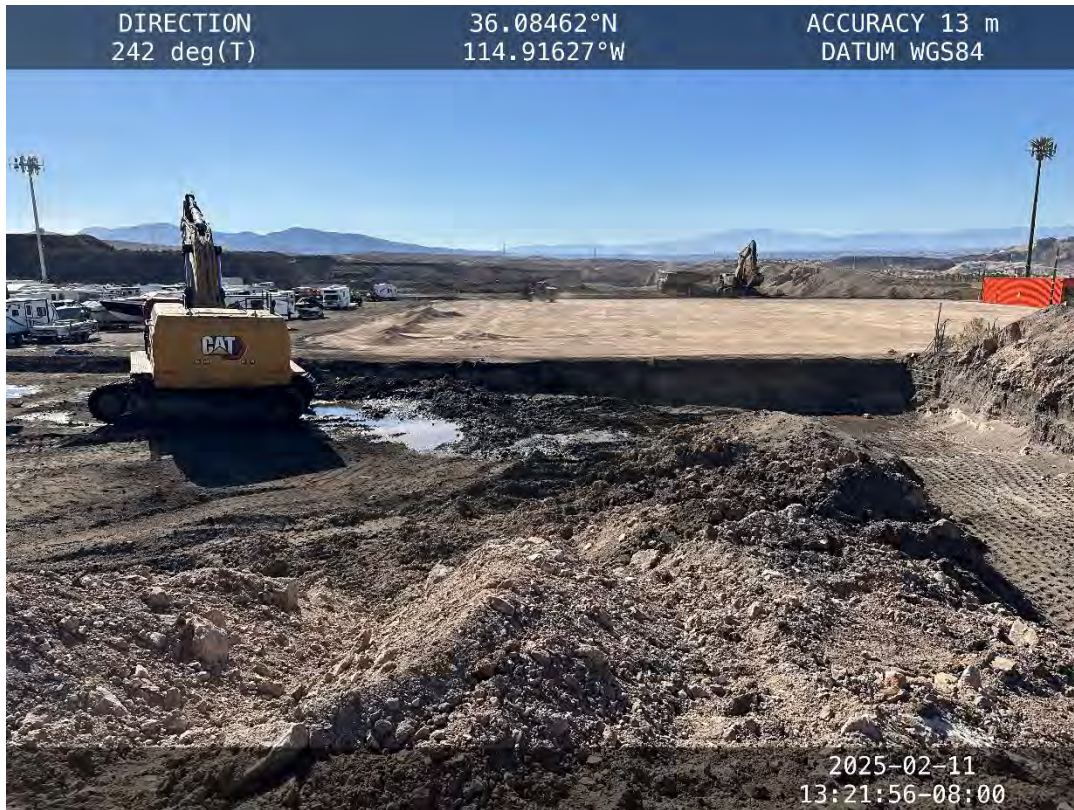
Tailings at Laker Plaza corner – February 11, 2025

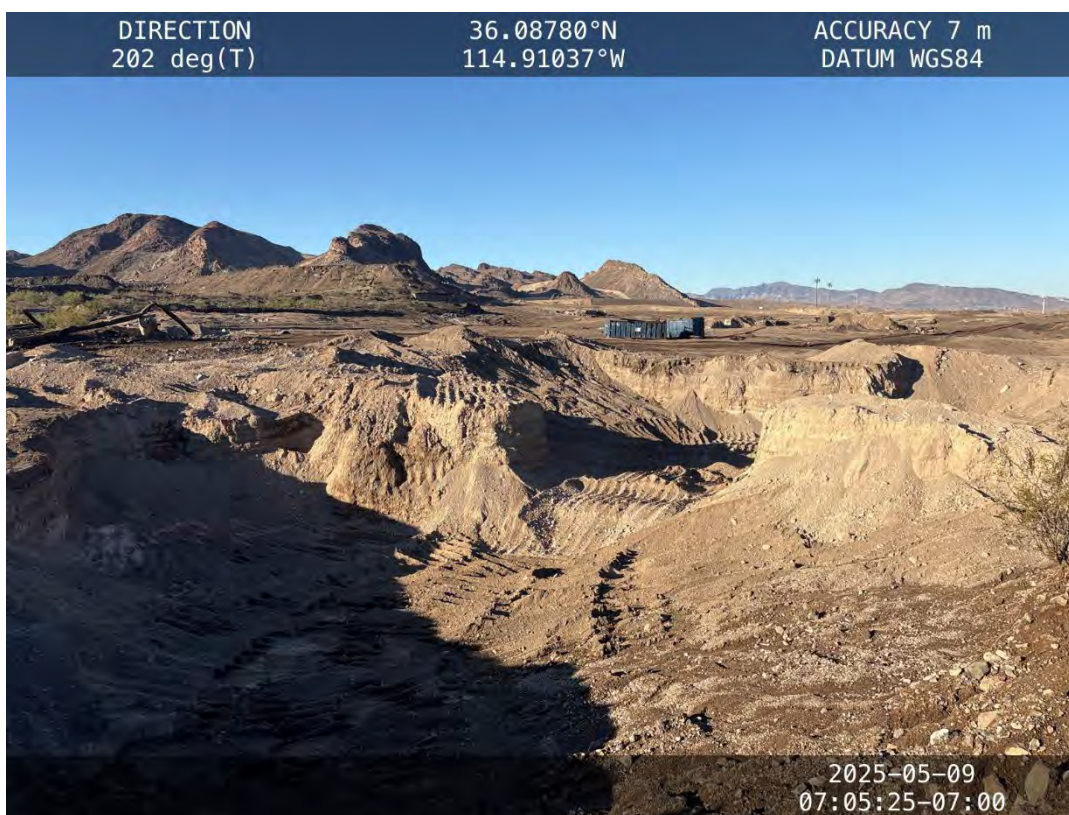
Fuel farm excavation – May 9, 2025

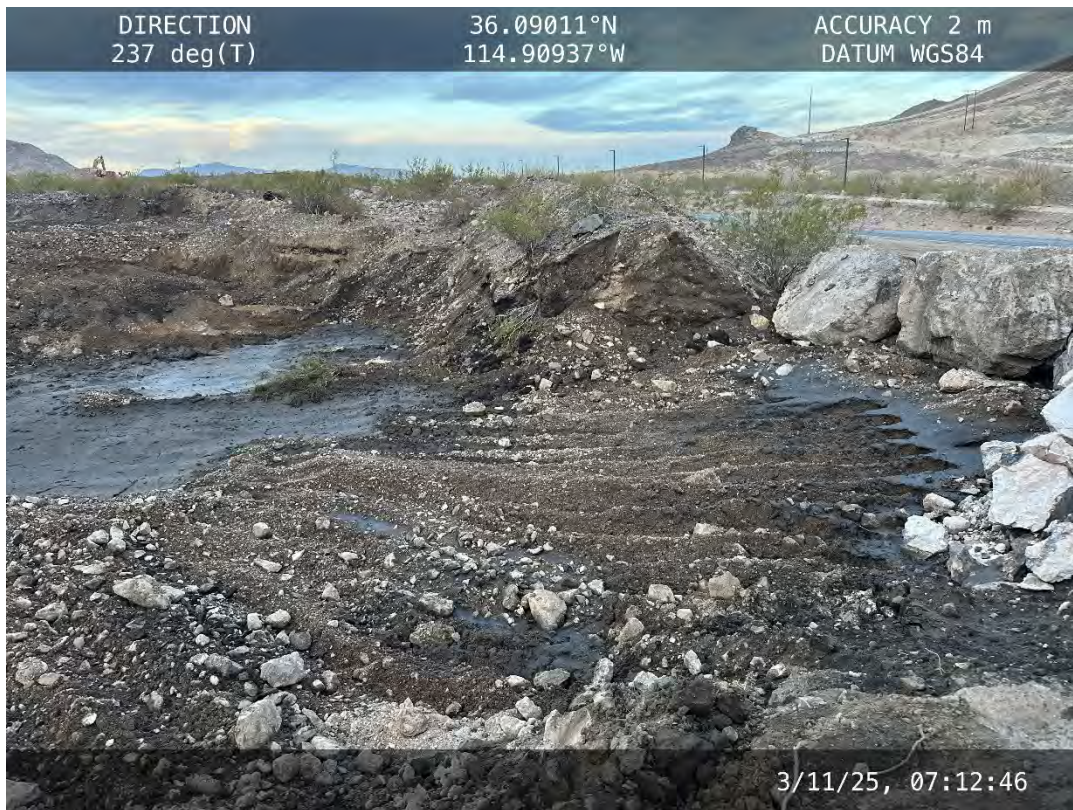
Northeast drainage – March 11, 2025

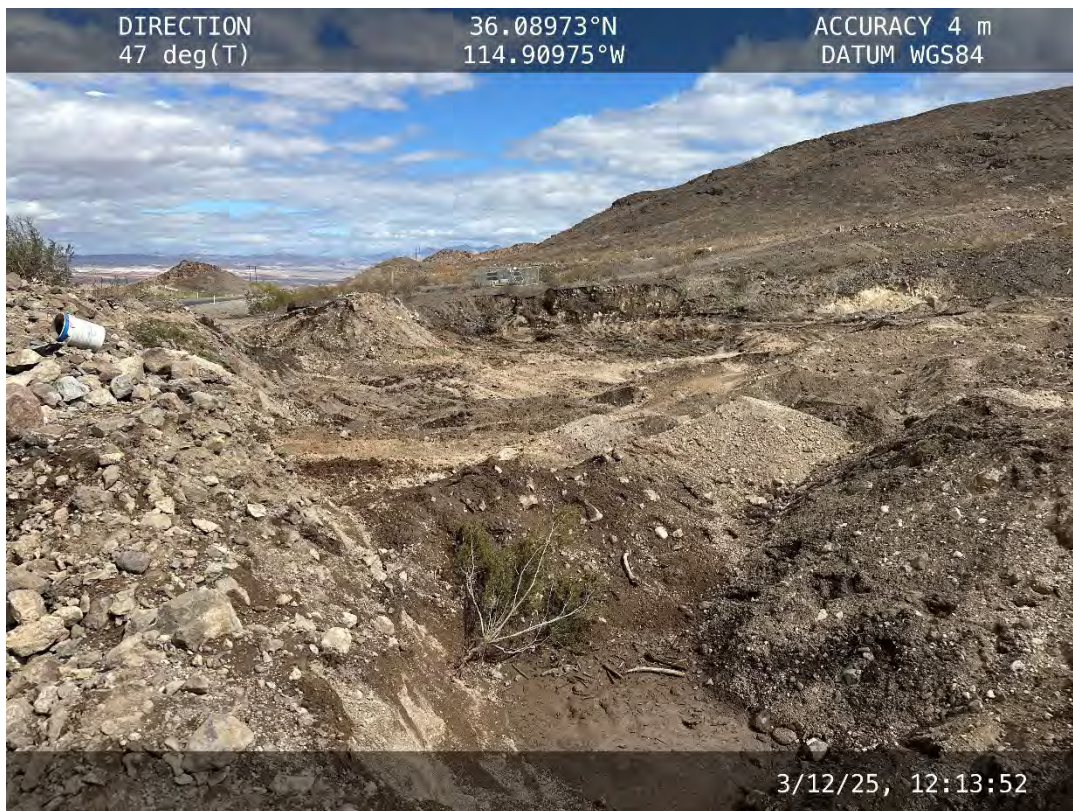
Northeast drainage – March 12, 2025
