**Closure Unit 4 Work Completion Report, Revision 1**  
Three Kids Mine  
Henderson, Nevada

Project No. 23-01-200

Re: **Closure Unit 4 Work Completion Report, Revision 1**  
Three Kids Mine, Henderson, Nevada

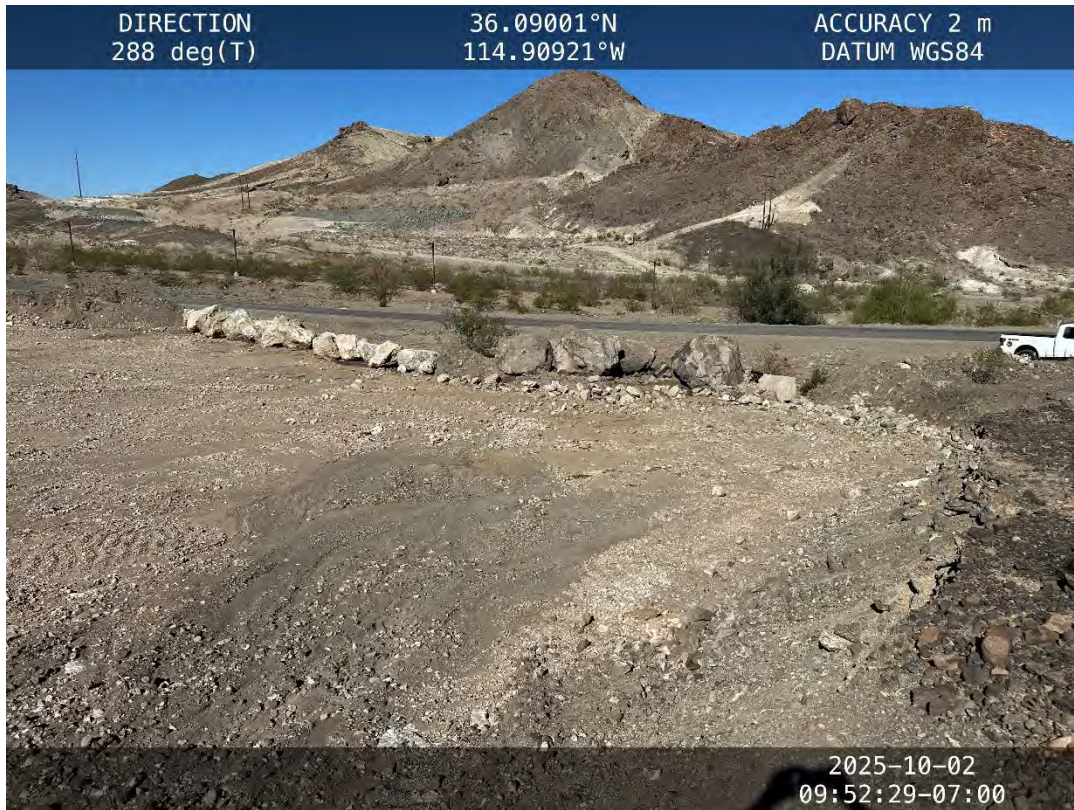
Northeast drainage – October 2, 2025

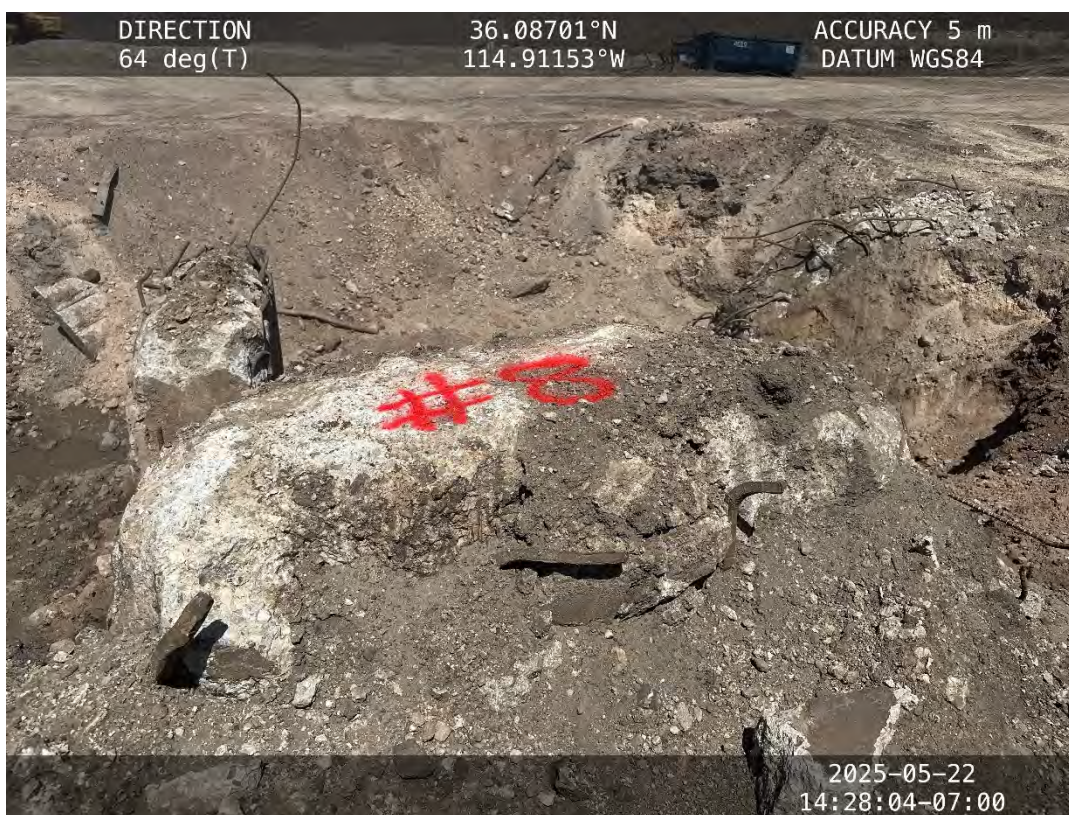
Location #8 – Concrete block

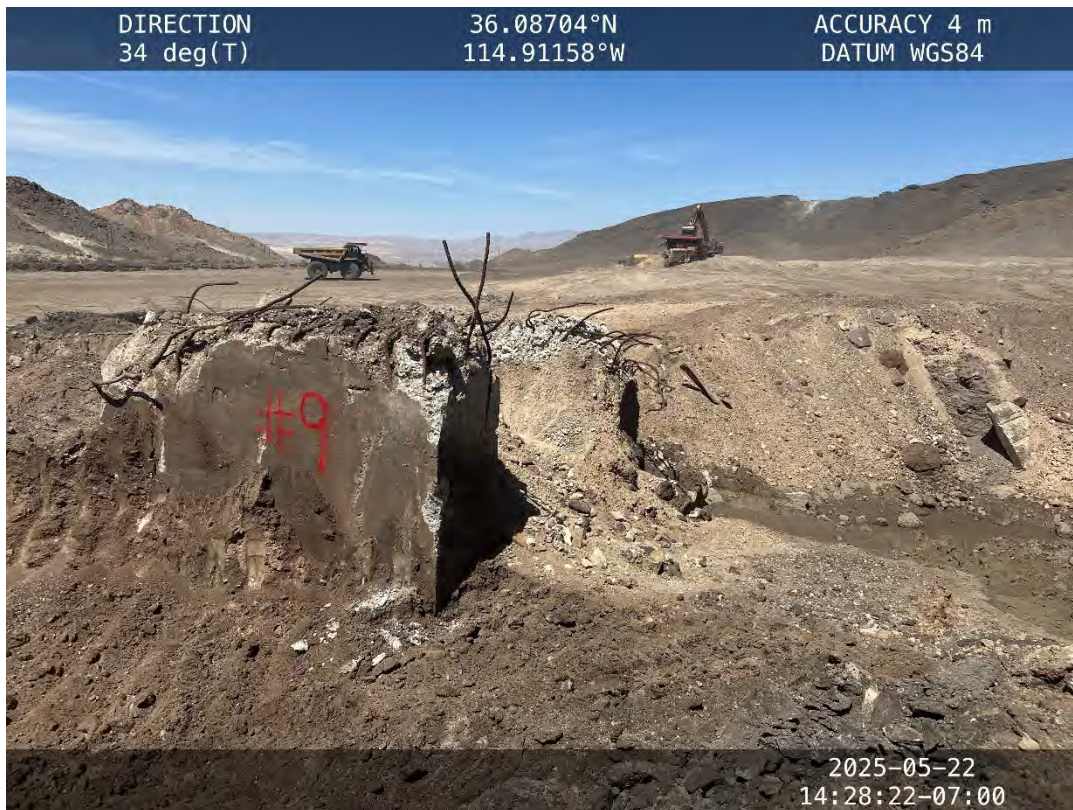
Location #9 – Concrete block

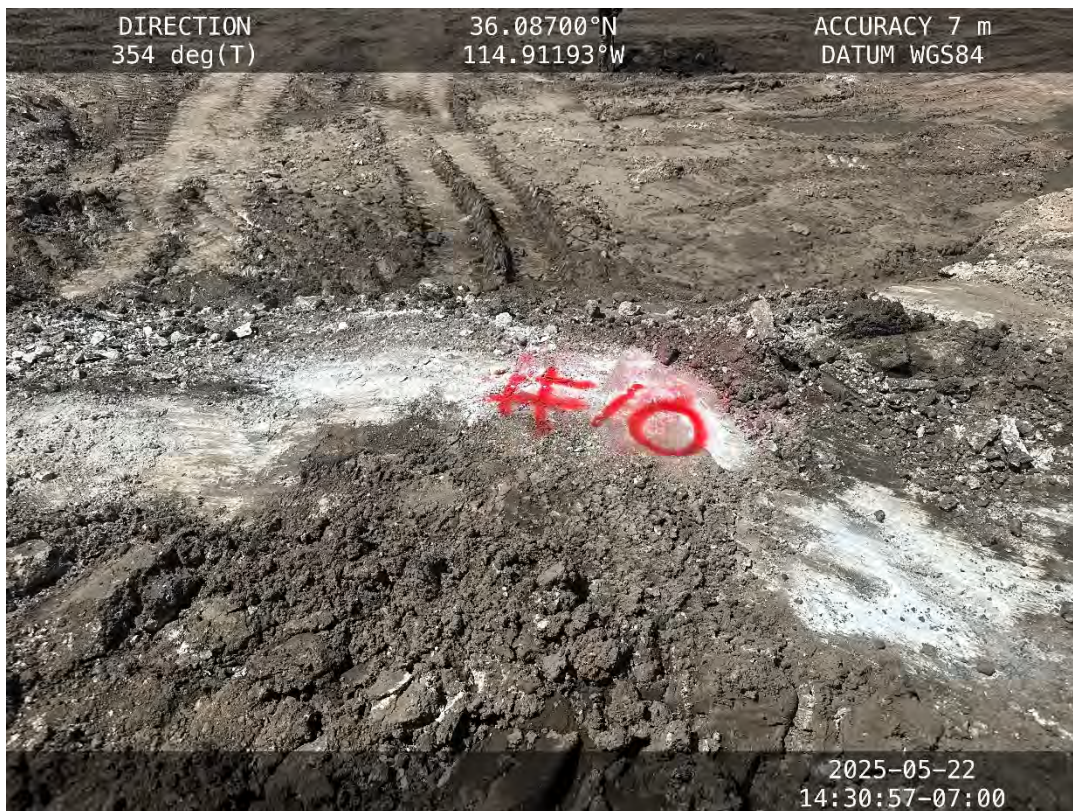
Location #10 – Hard material, concrete or gypsum bedrock

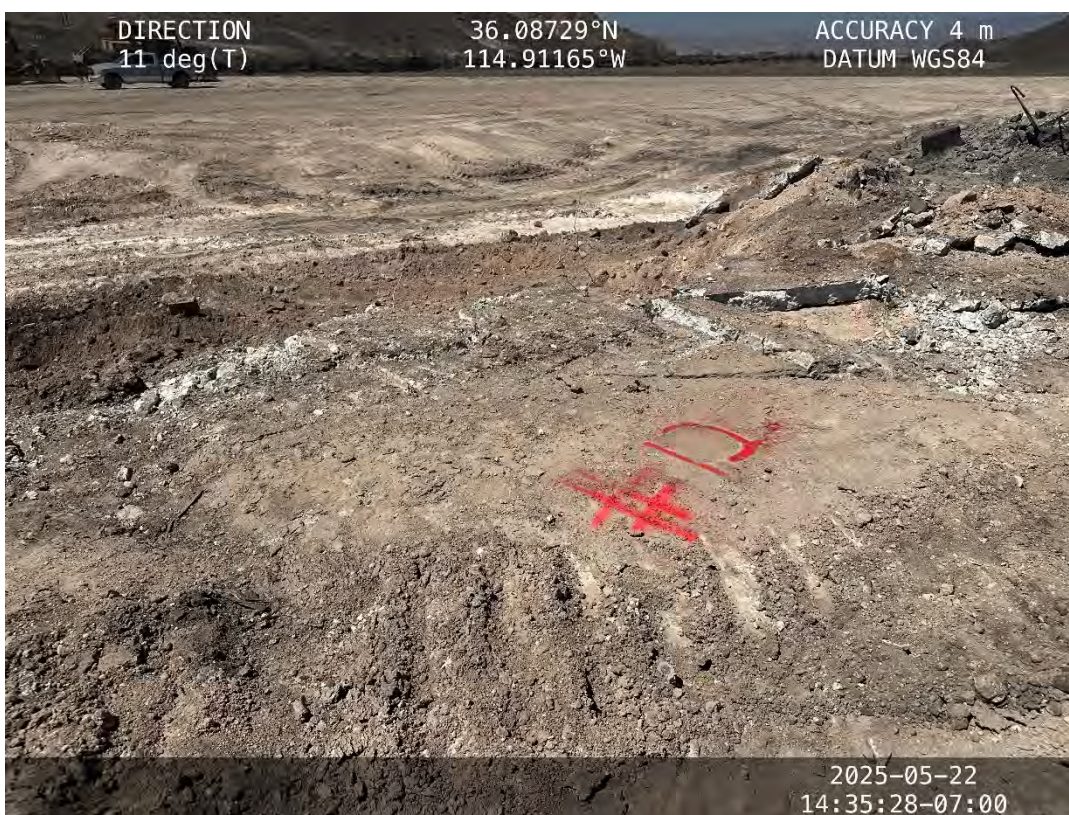
Location #12 – Concrete wall (west end)

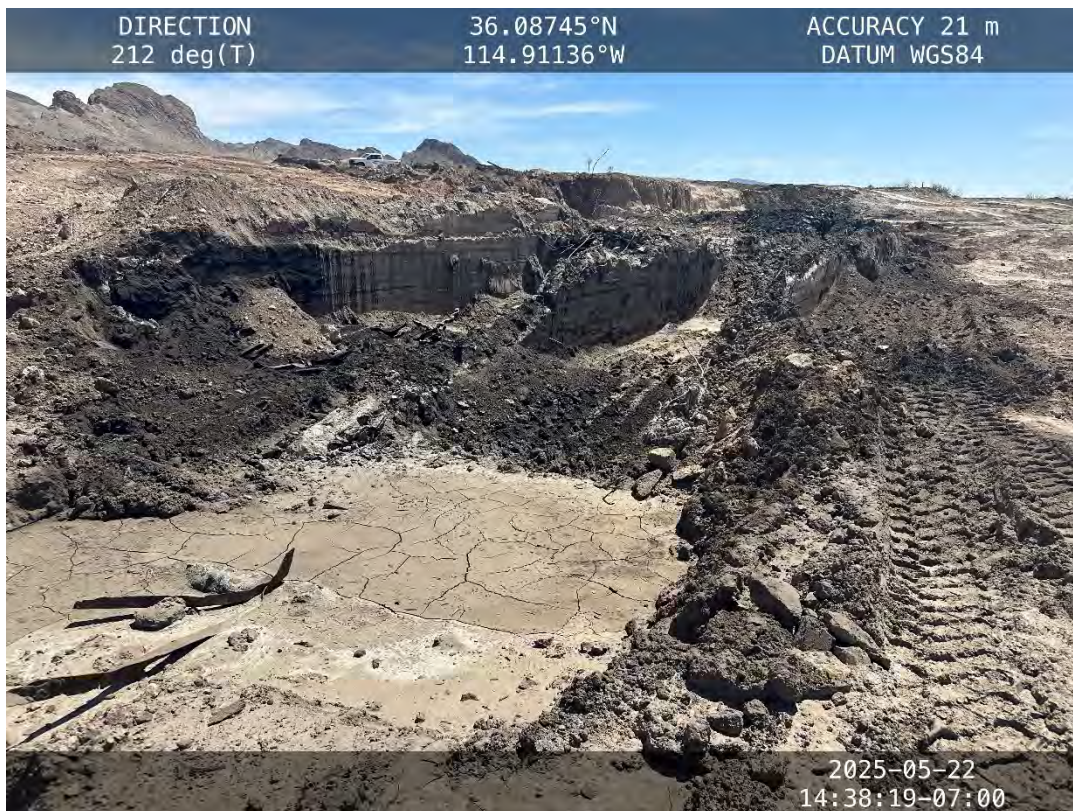
Location #12 – Concrete wall

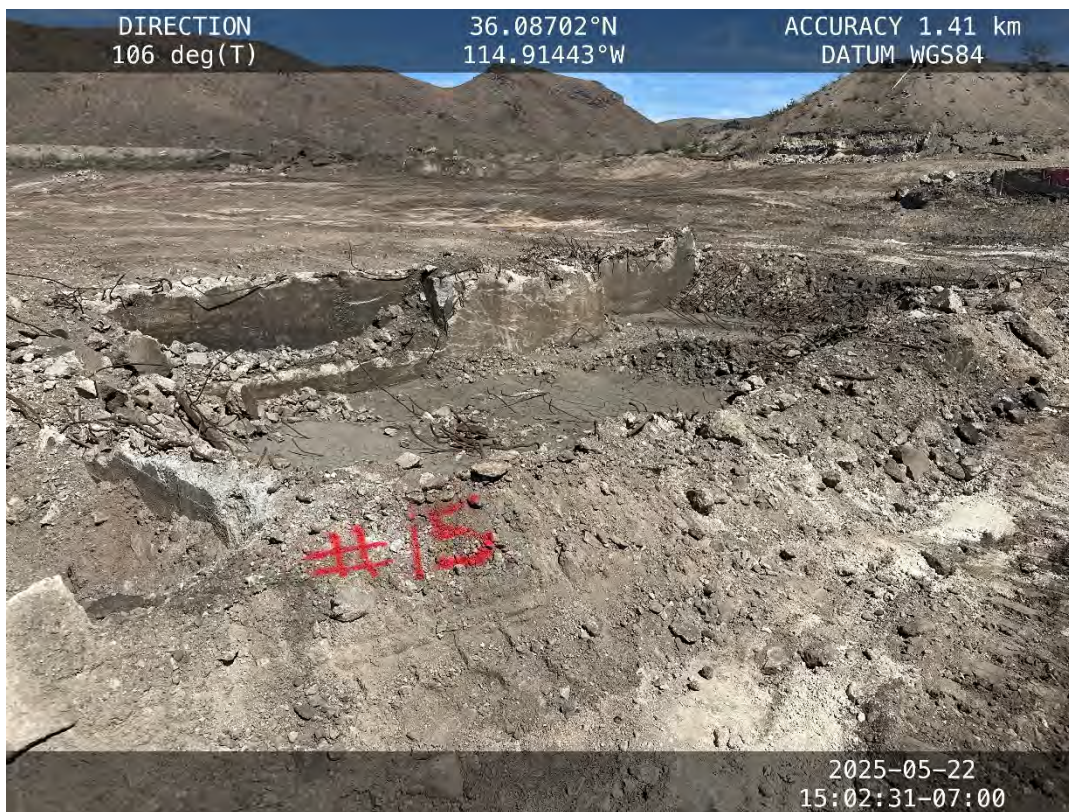
**Location #15 – Concrete foundation**

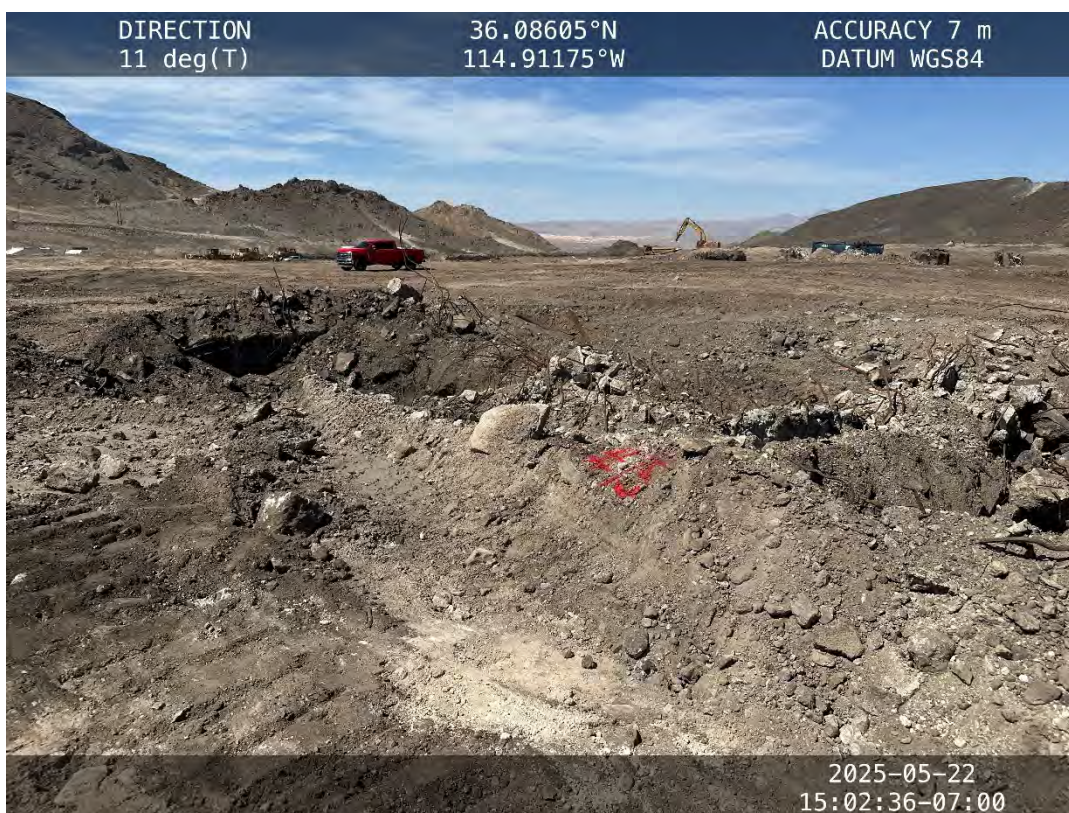
**Location #15 – Concrete foundation**

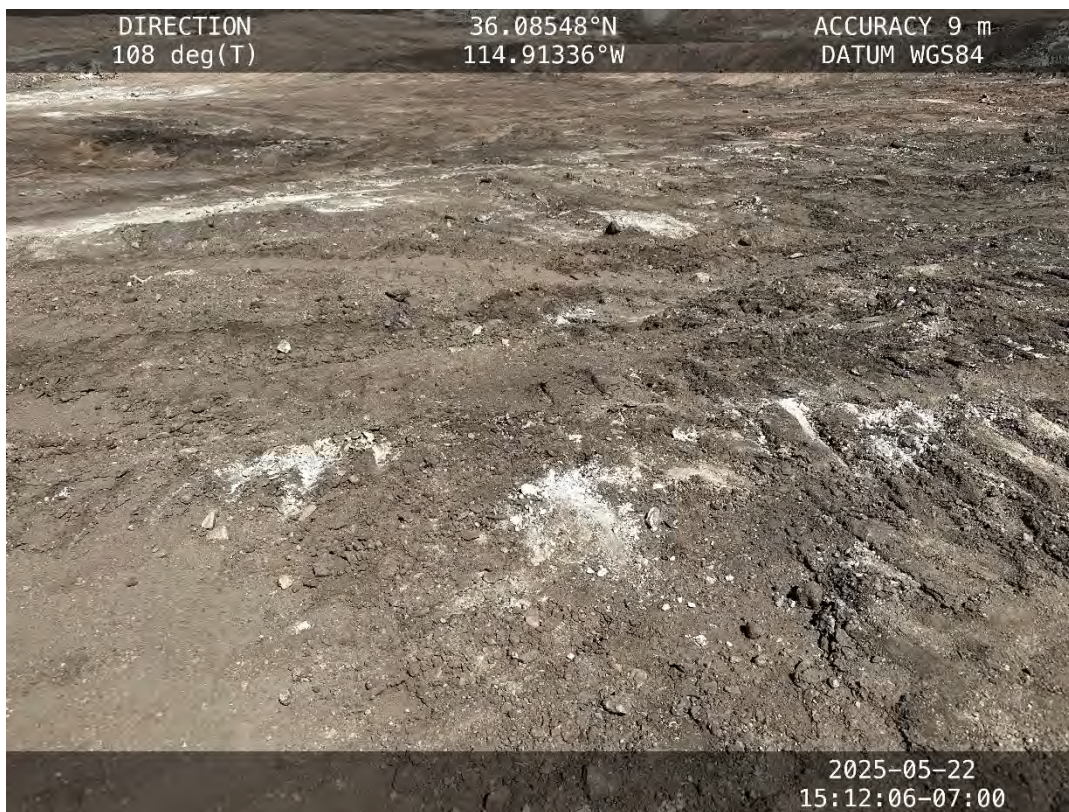
**Location #16 – Hard gypsum bedrock**

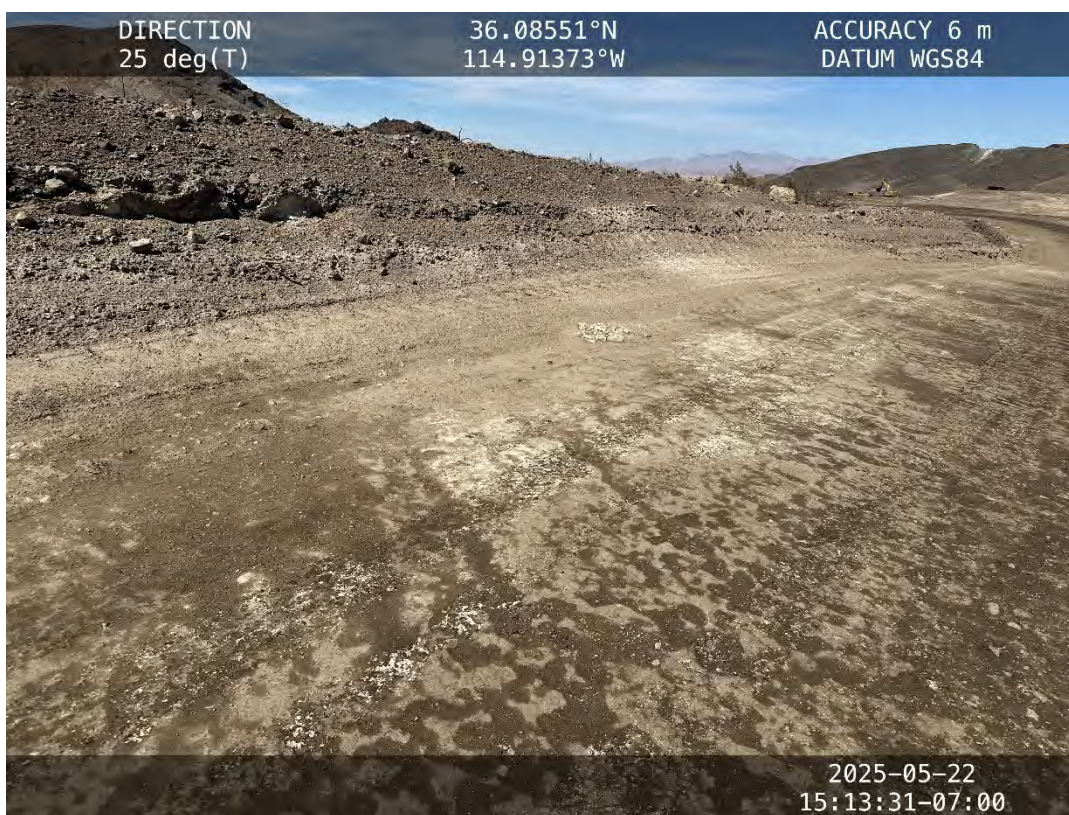
**Location #17 - Hard gypsum bedrock**

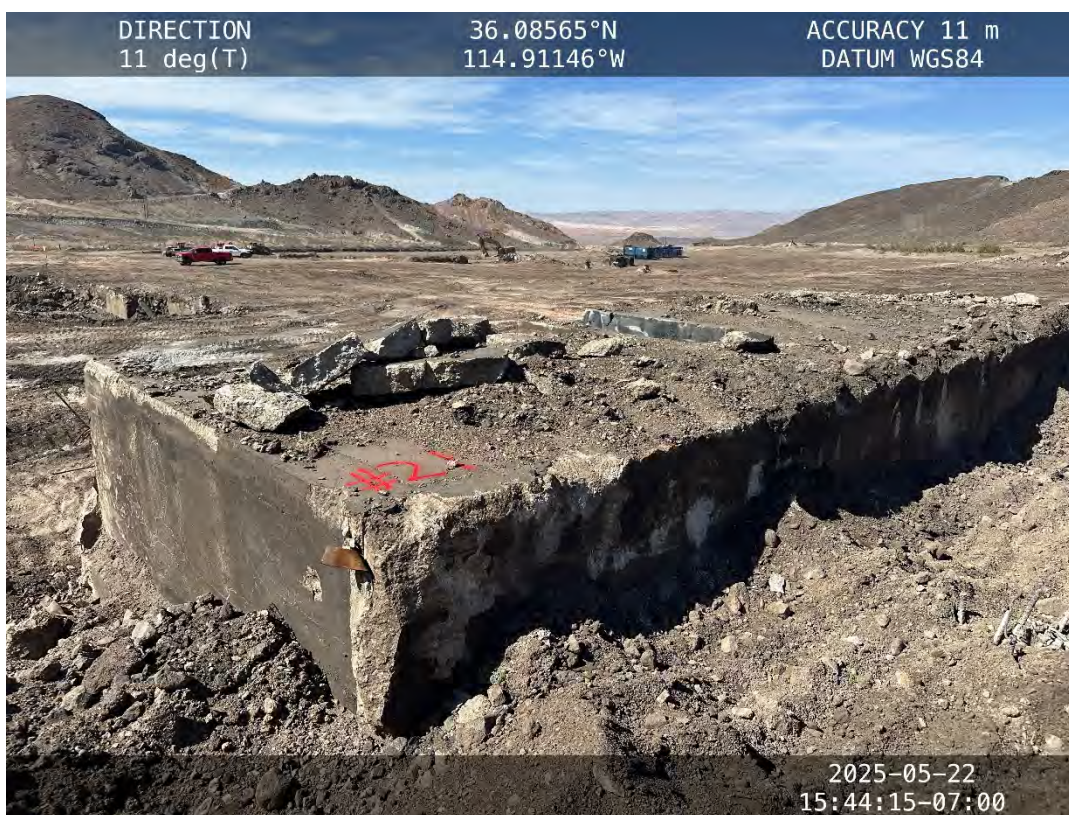
Location #21 – Concrete block

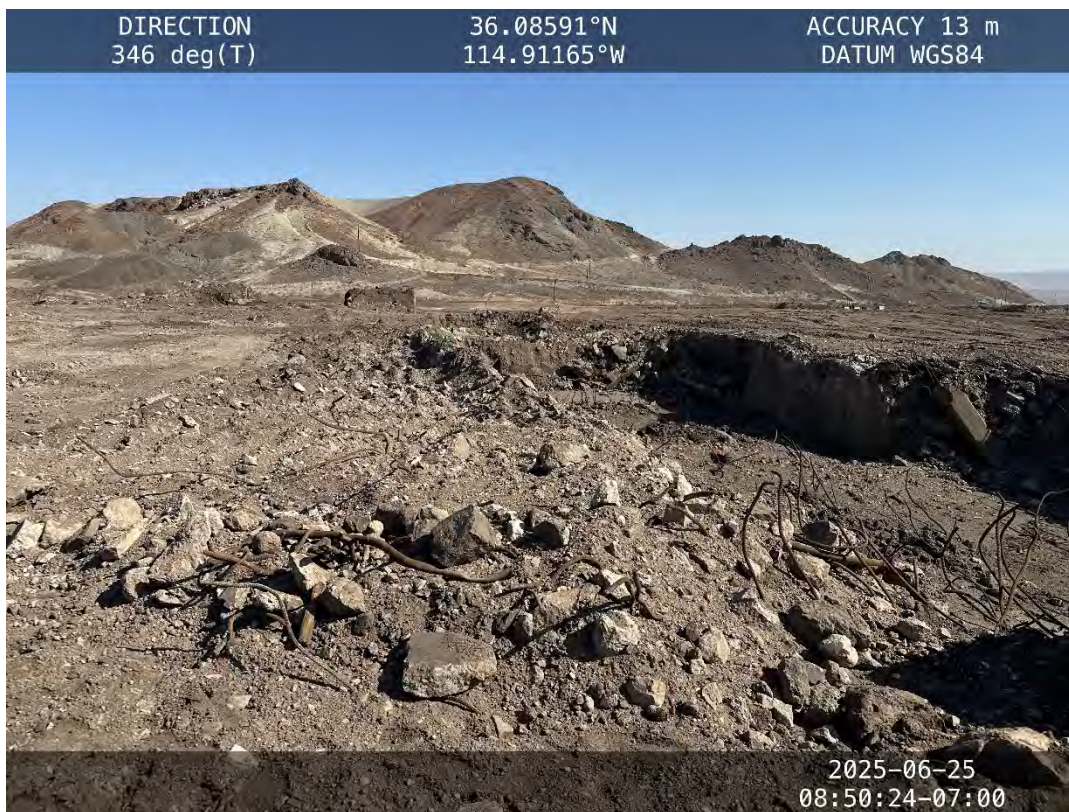
Location #34 - Concrete foundation

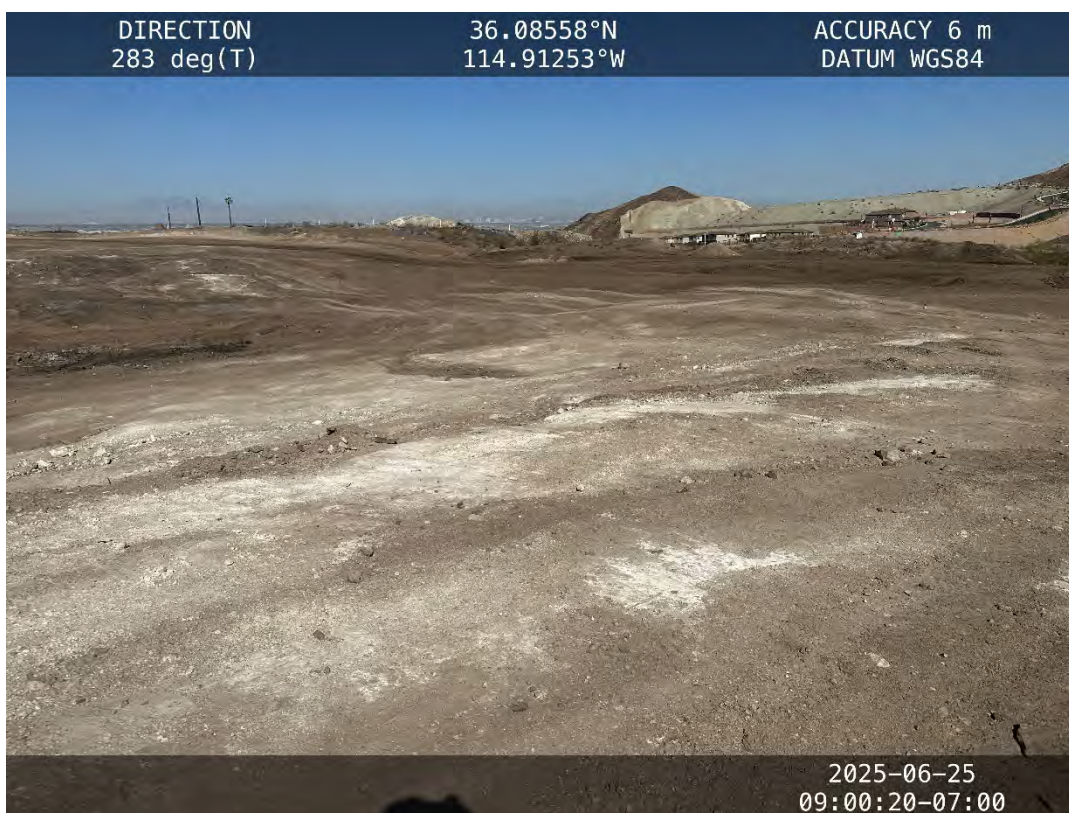
Location #35 – Hard bedrock

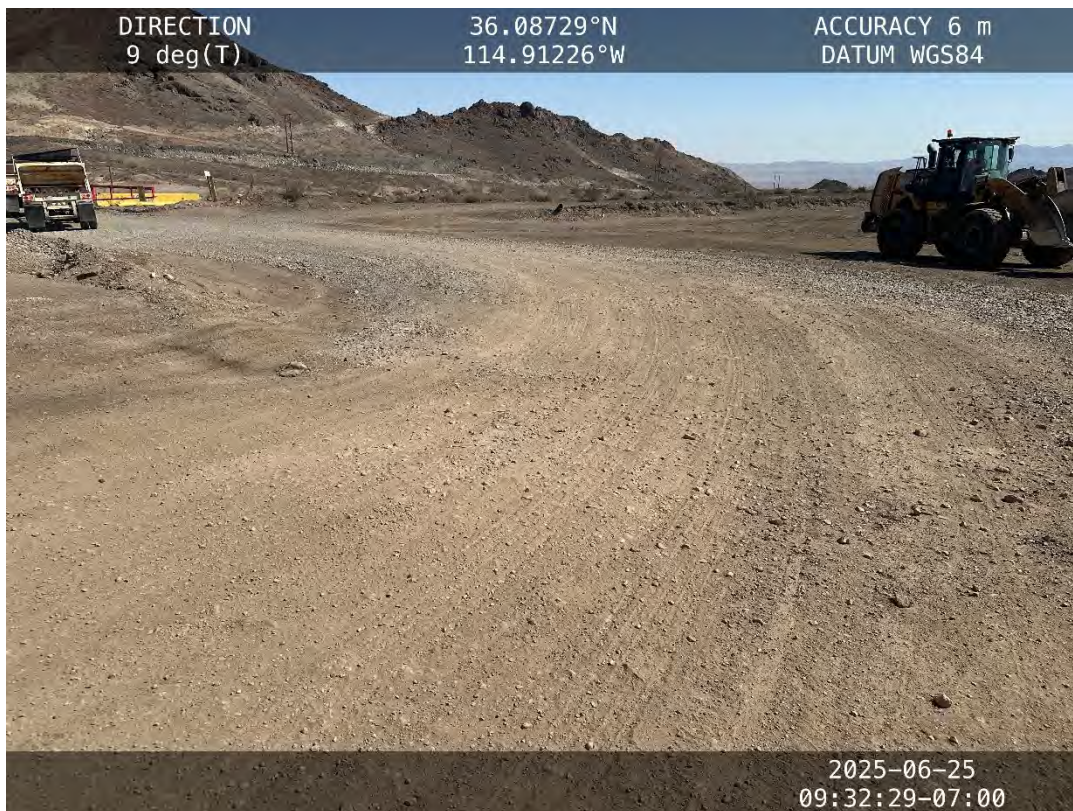
Location #37 – Haul road constructed over excavation area with track-out rock
