**Closure Unit 4 Work Completion Report, Revision 1**  
Three Kids Mine  
Henderson, Nevada

Project No. 23-01-200

Re: **Closure Unit 4 Work Completion Report, Revision 1**  
Three Kids Mine, Henderson, Nevada

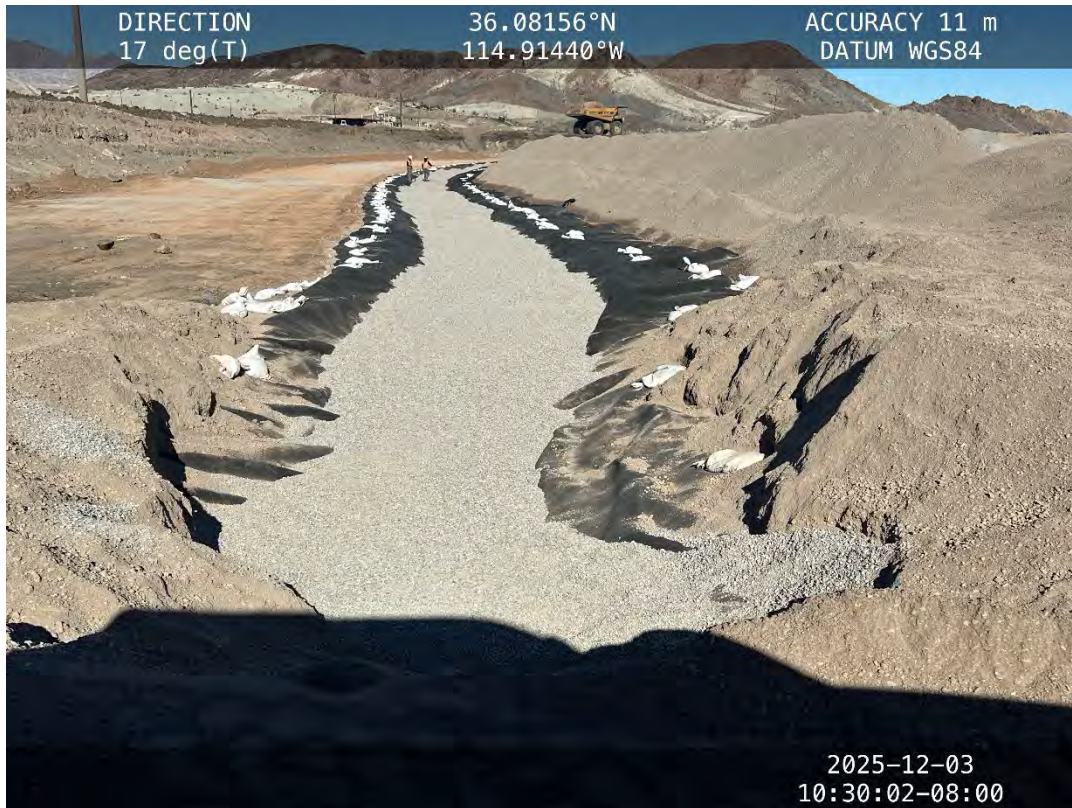
Hydro Pit drainage channels backfilled with Zone 3 material – December 3, 2025

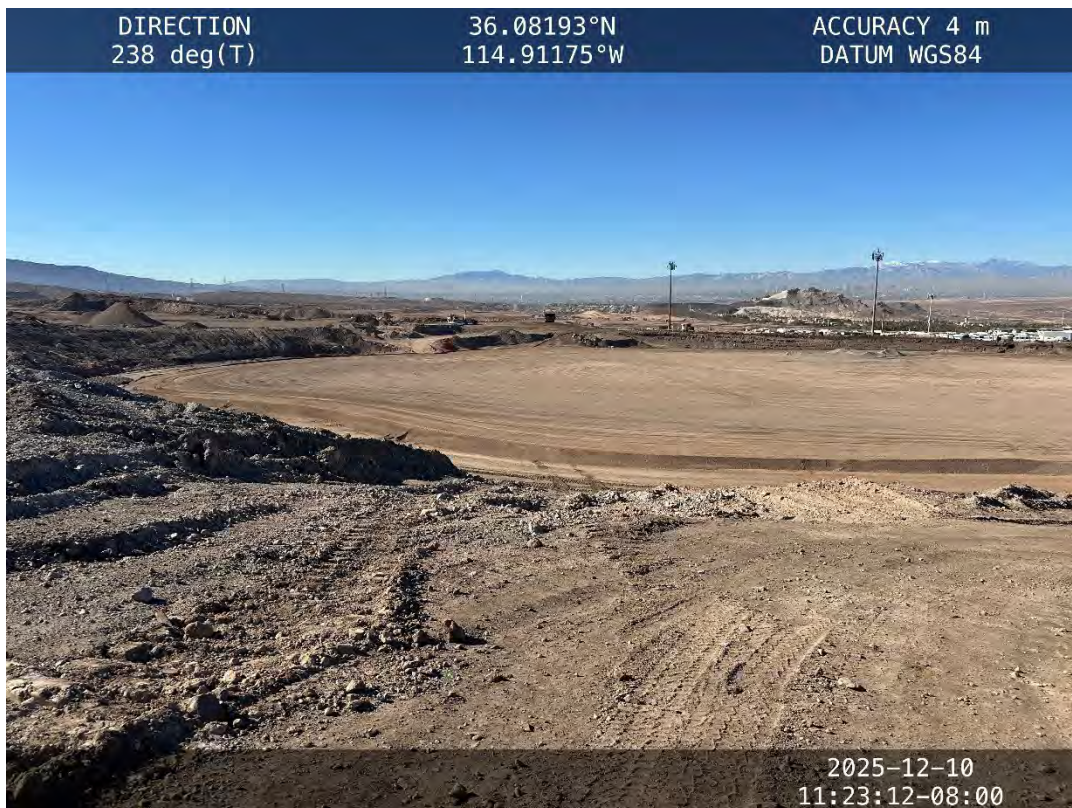
Two-foot cover over Hydro Pit liner – December 10, 2025

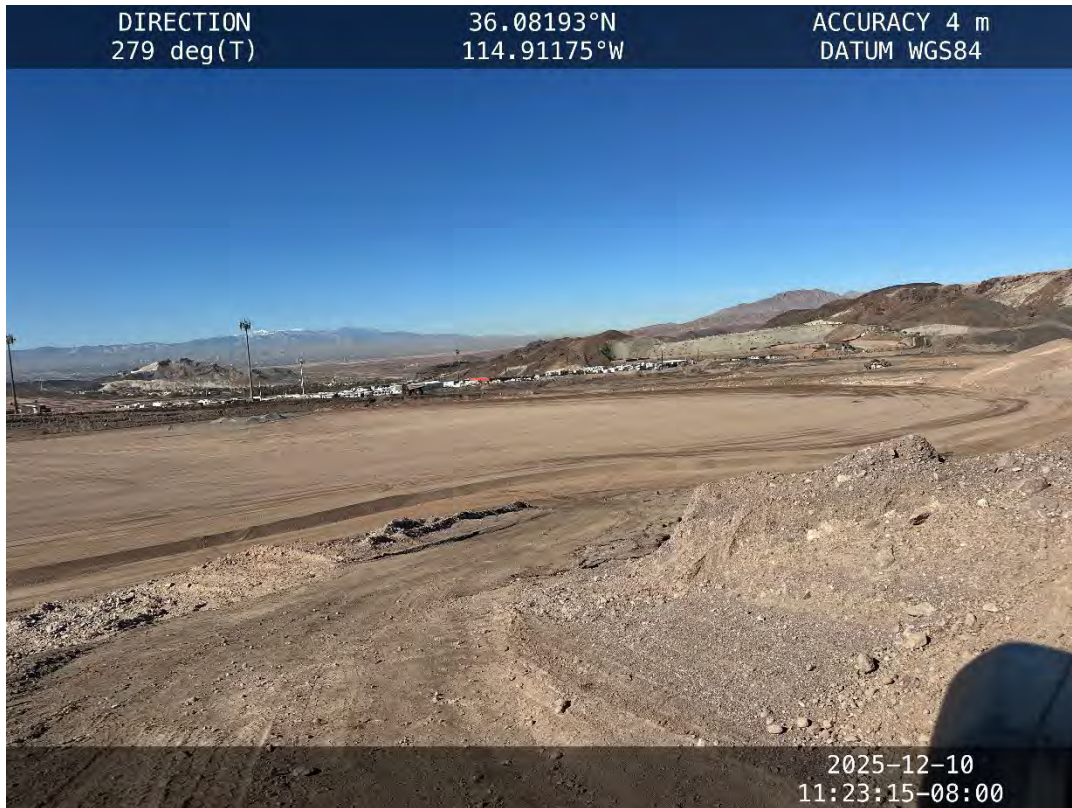
Two-foot cover over Hydro Pit liner – December 10, 2025

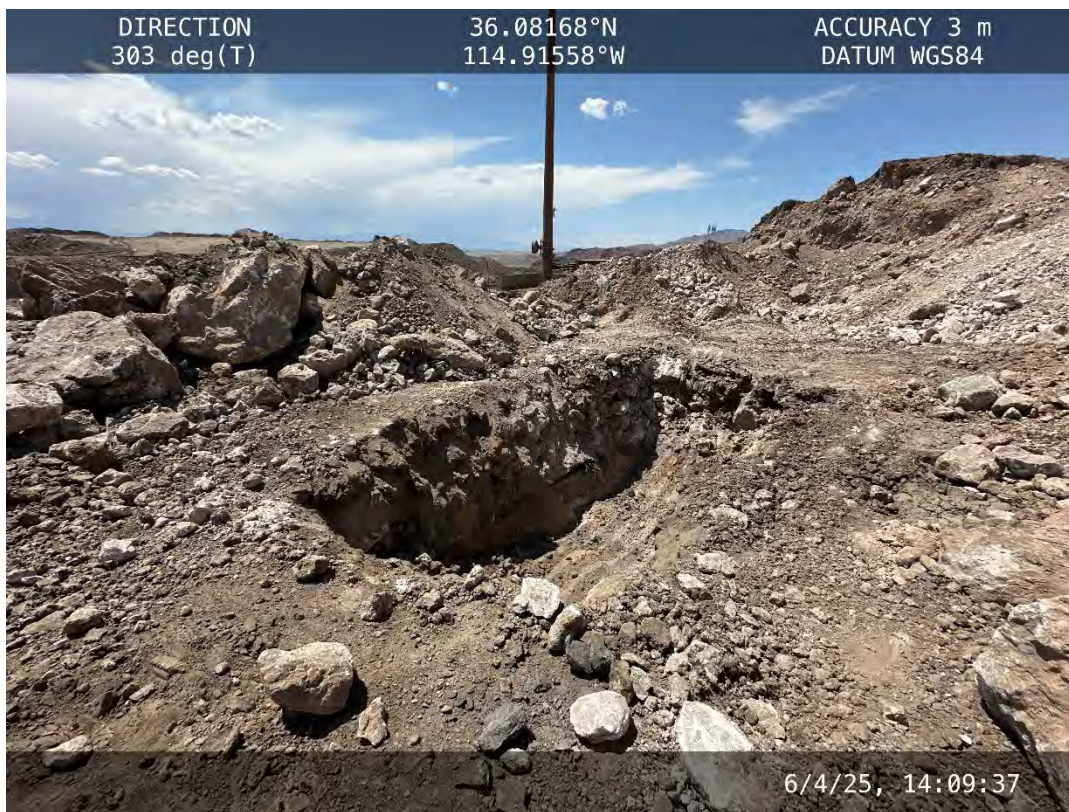
Tailings seam southeast of Tailings Pond 1 – June 4, 2025

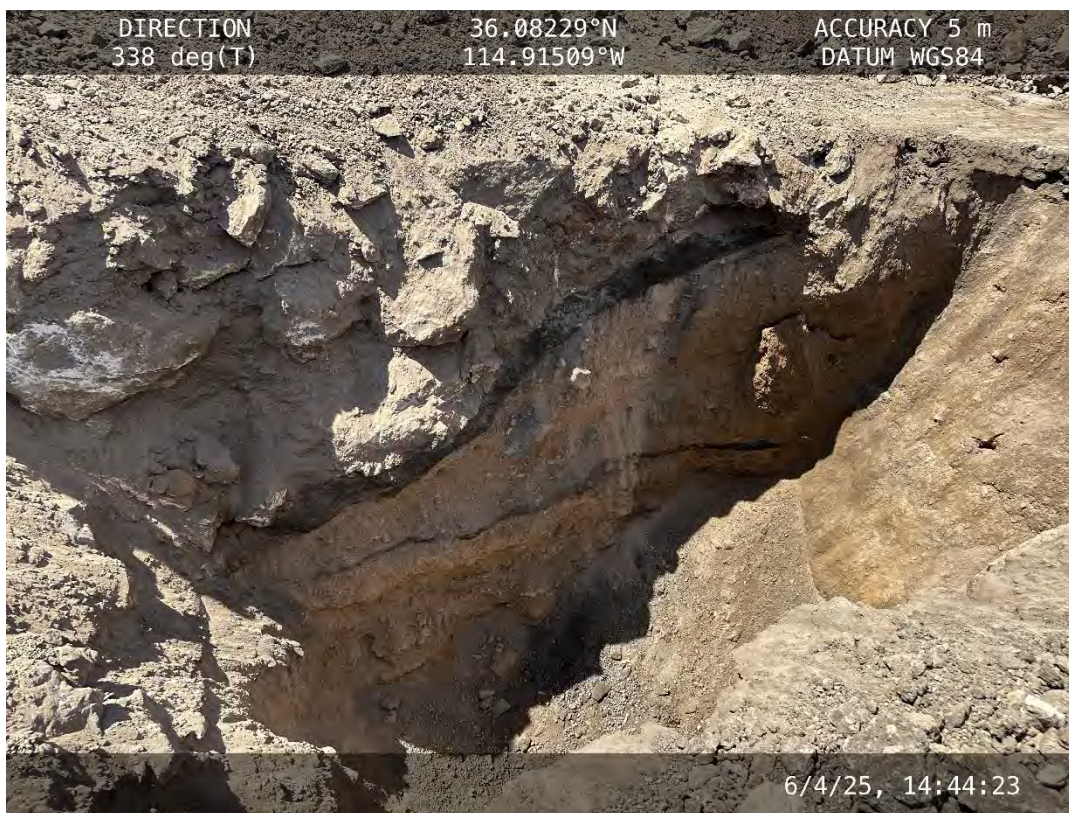
Tailings seam southeast of Tailings Pond 1 – June 4, 2025

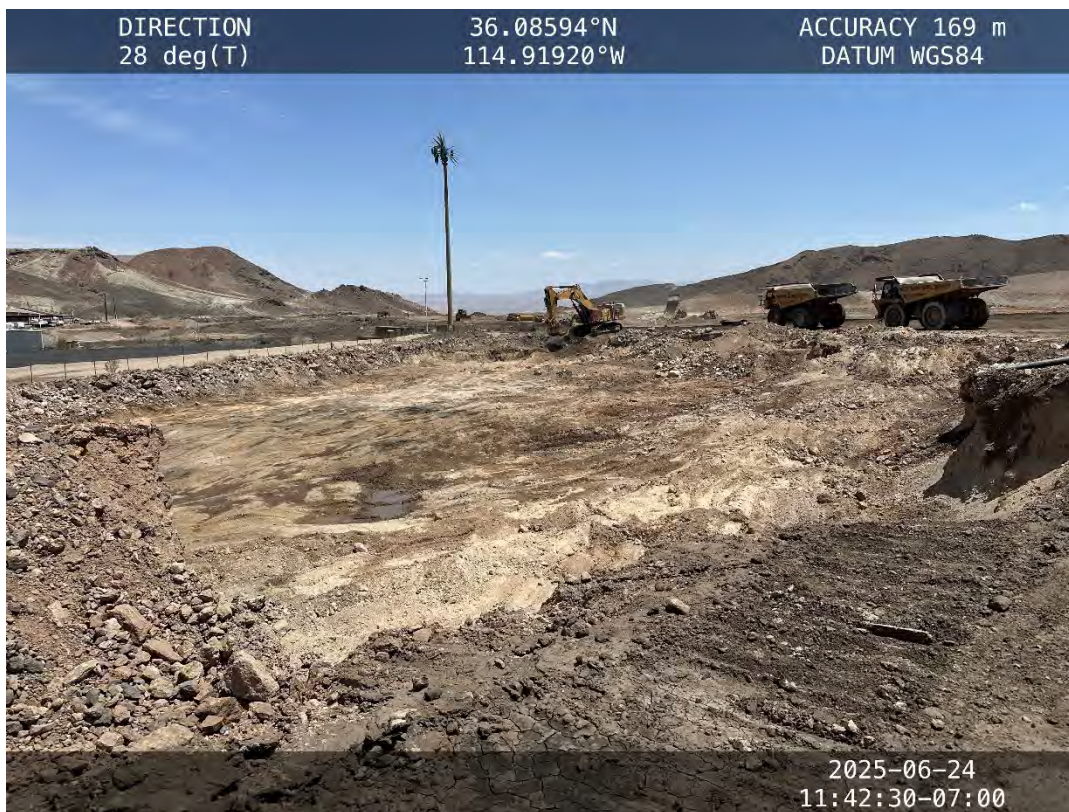
**Tailings seam southeast of Tailings Pond 1 – June 24, 2025**

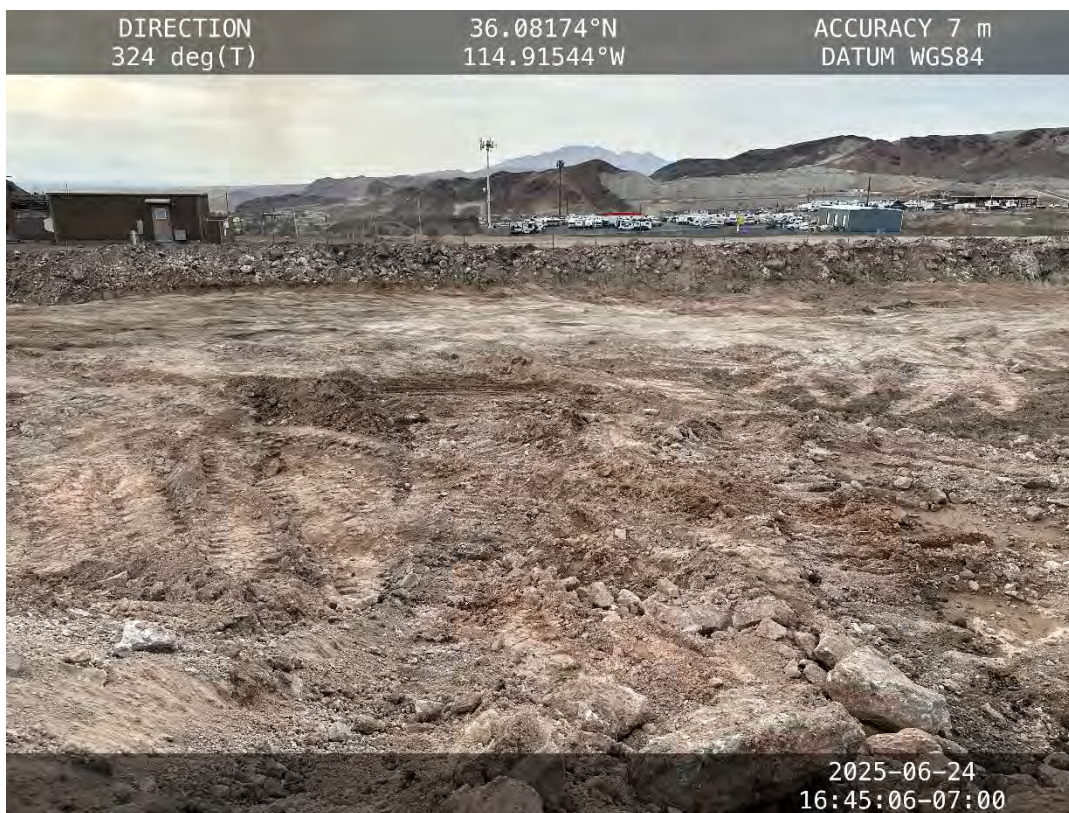
**Cleared area from tailings seam southeast of Tailings Pond 1 – June 24, 2025**

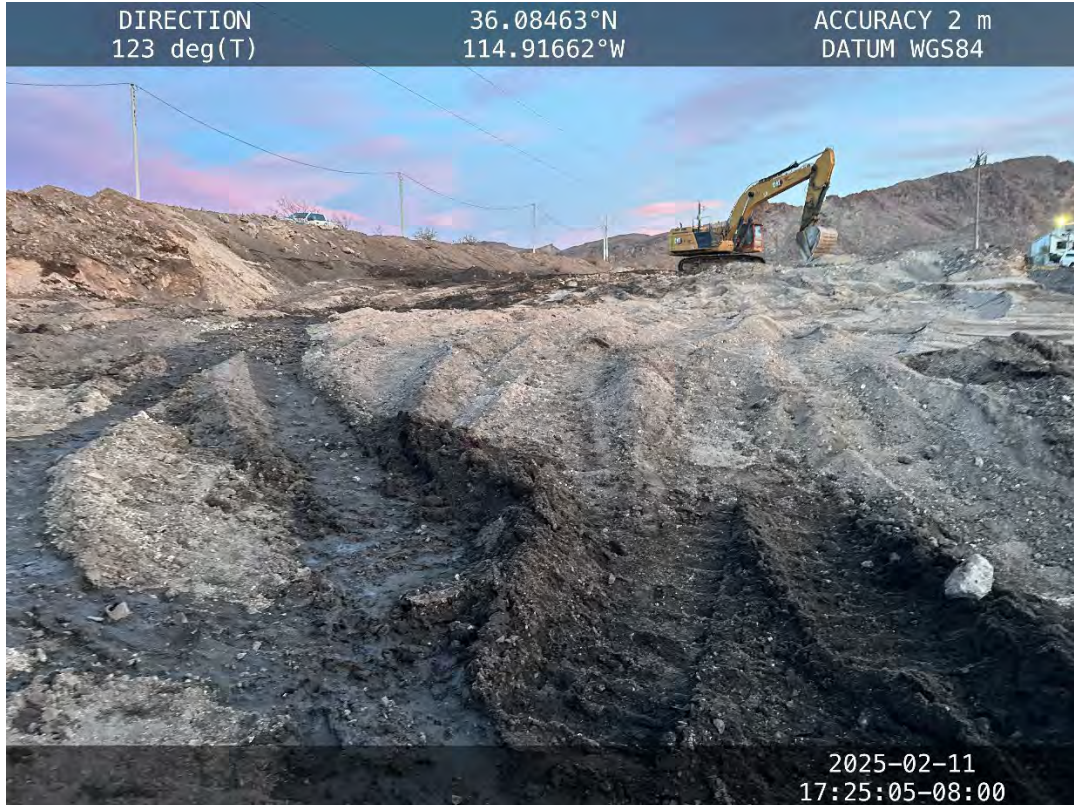
Laker Plaza corner after tailings removal – February 11, 2025

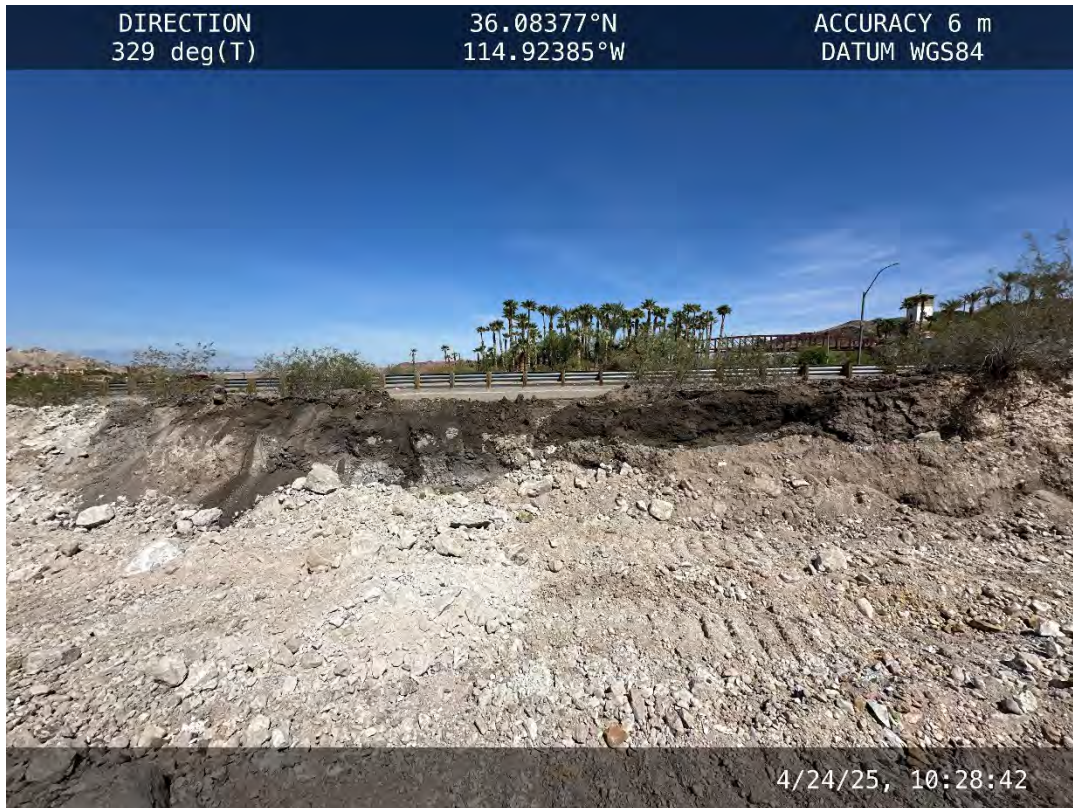
Tailings from north end of Closure Unit 3b/Development Area 4 – April 24, 2025

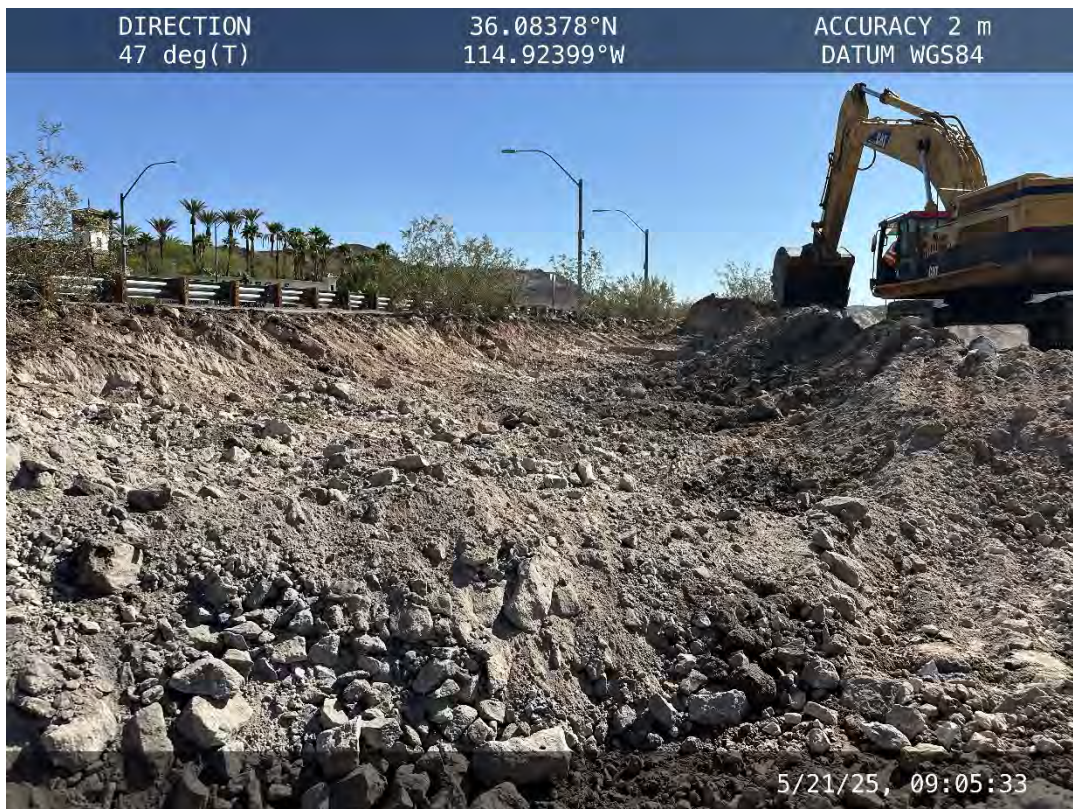
Tailings from north end of Closure Unit 3b/Development Area 4 – May 21, 2025

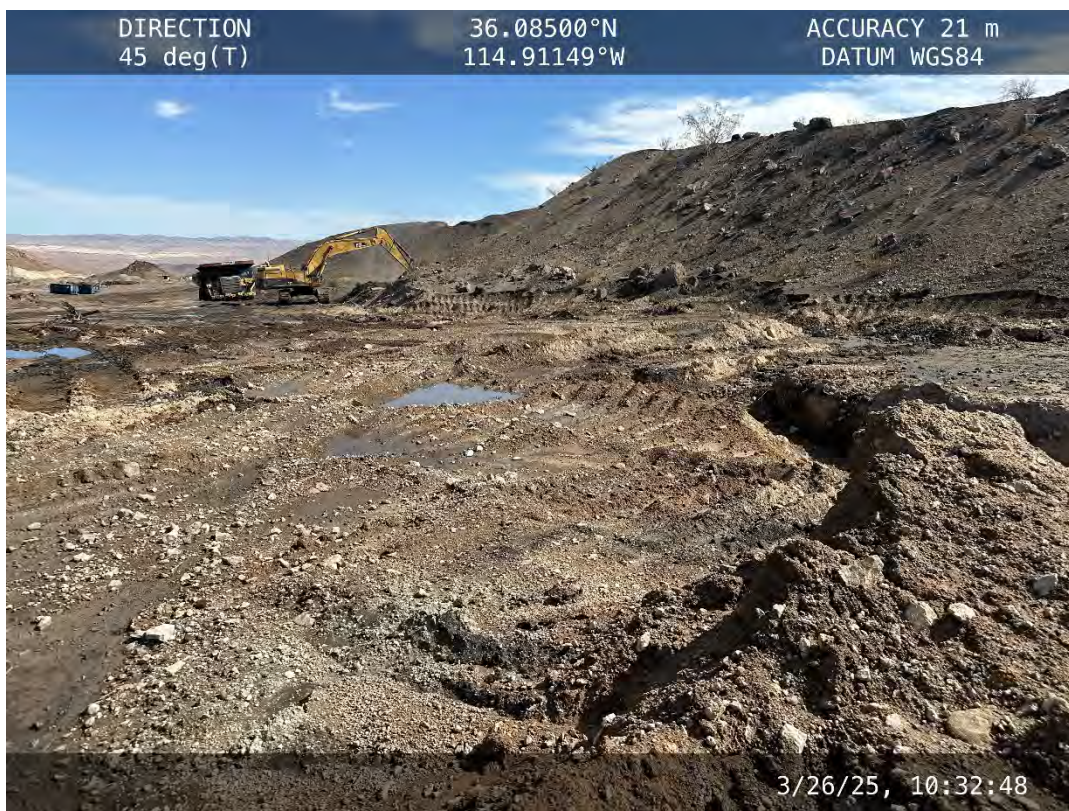
Tailings removal from Mill Site southeast of flotation cells – March 26, 2025

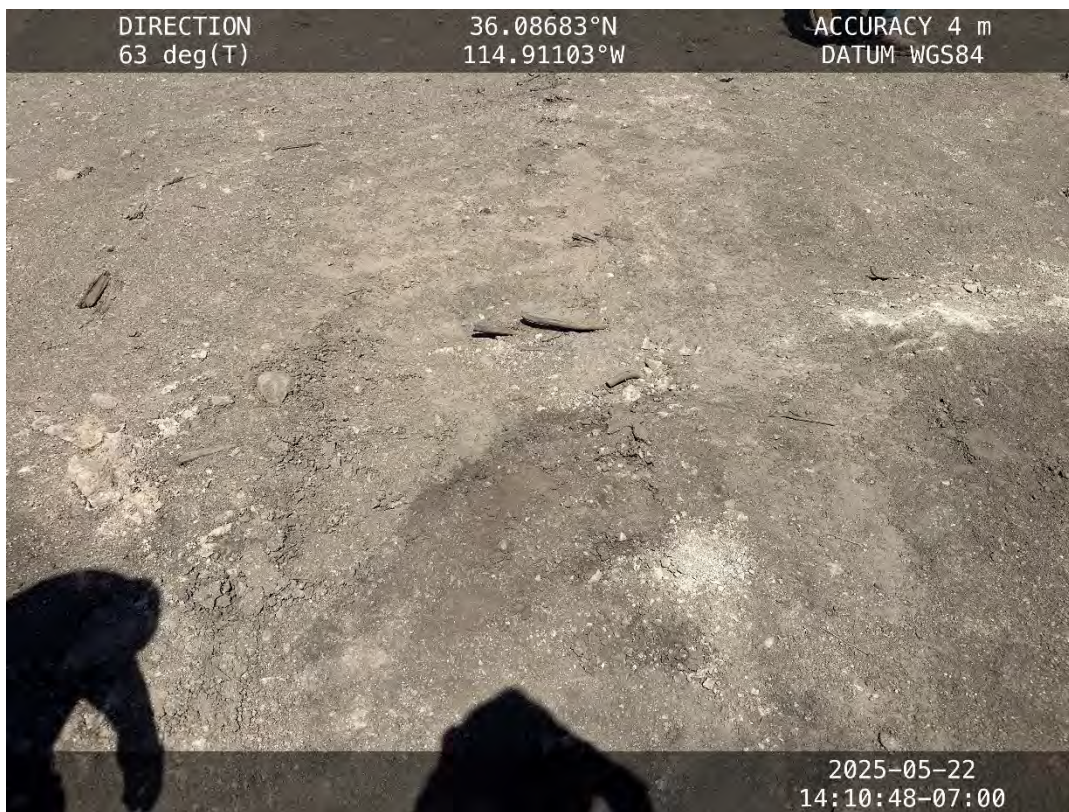
Location #1 – Concrete pad

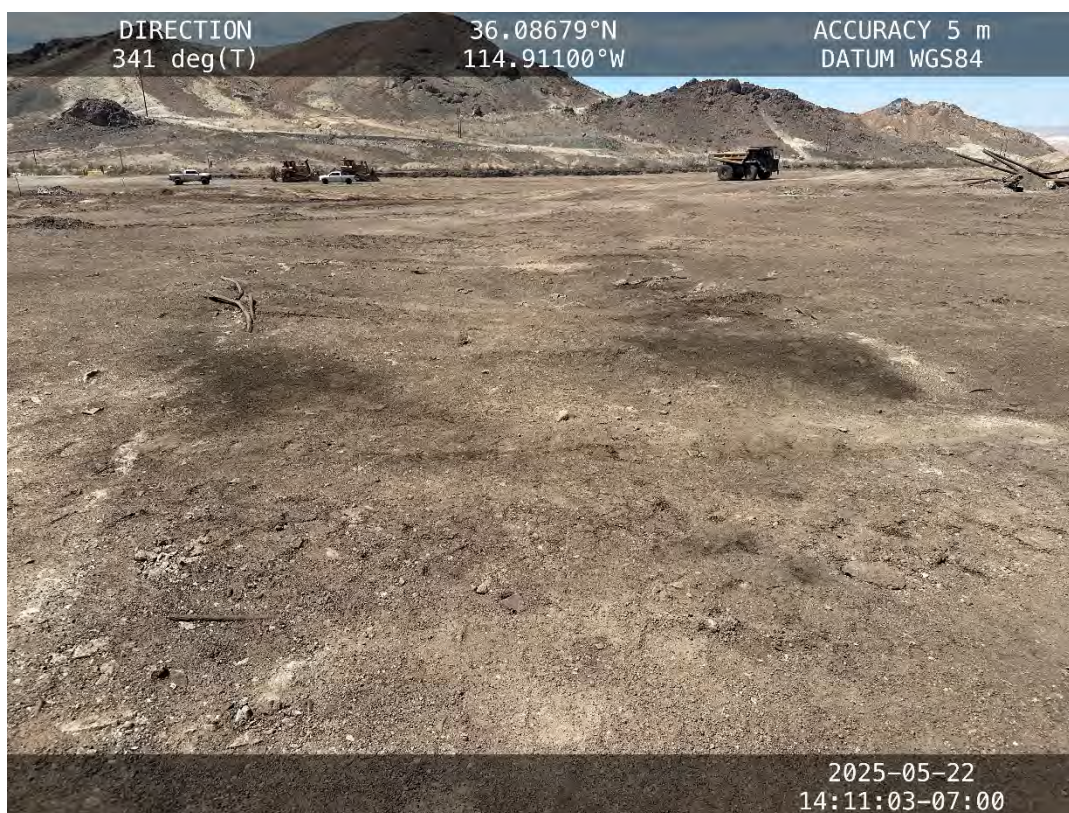
Location #1 – Concrete pad

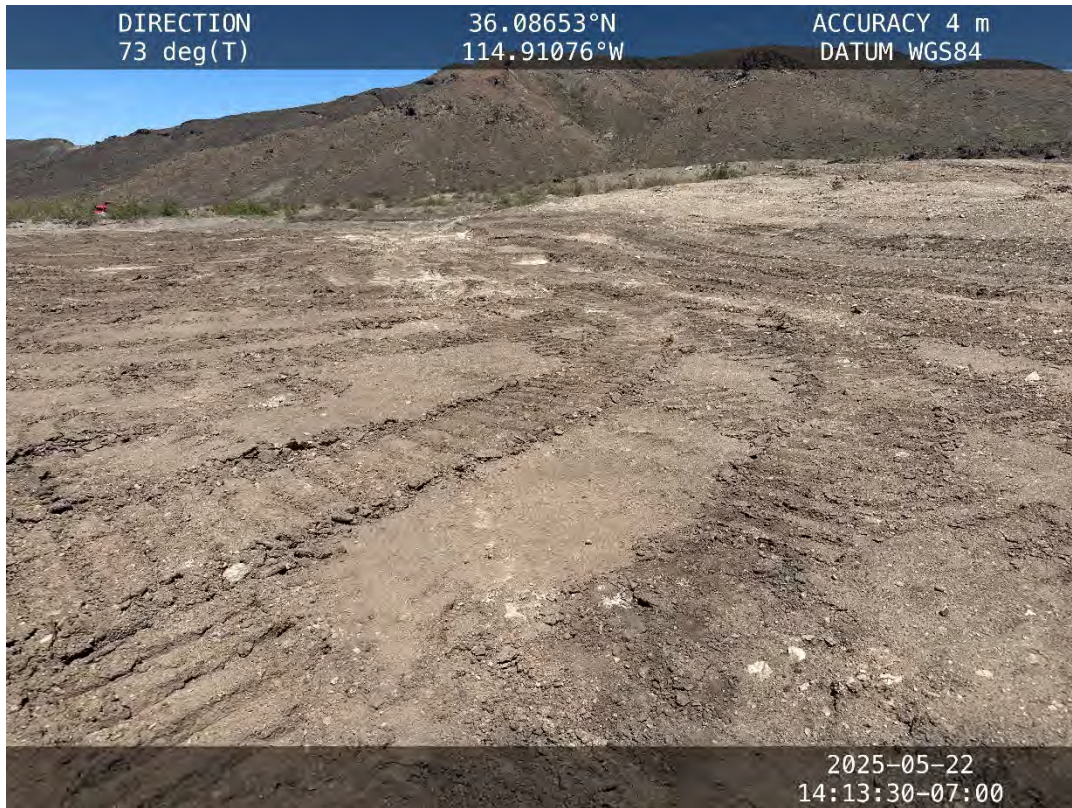
Location #2 – Concrete pad

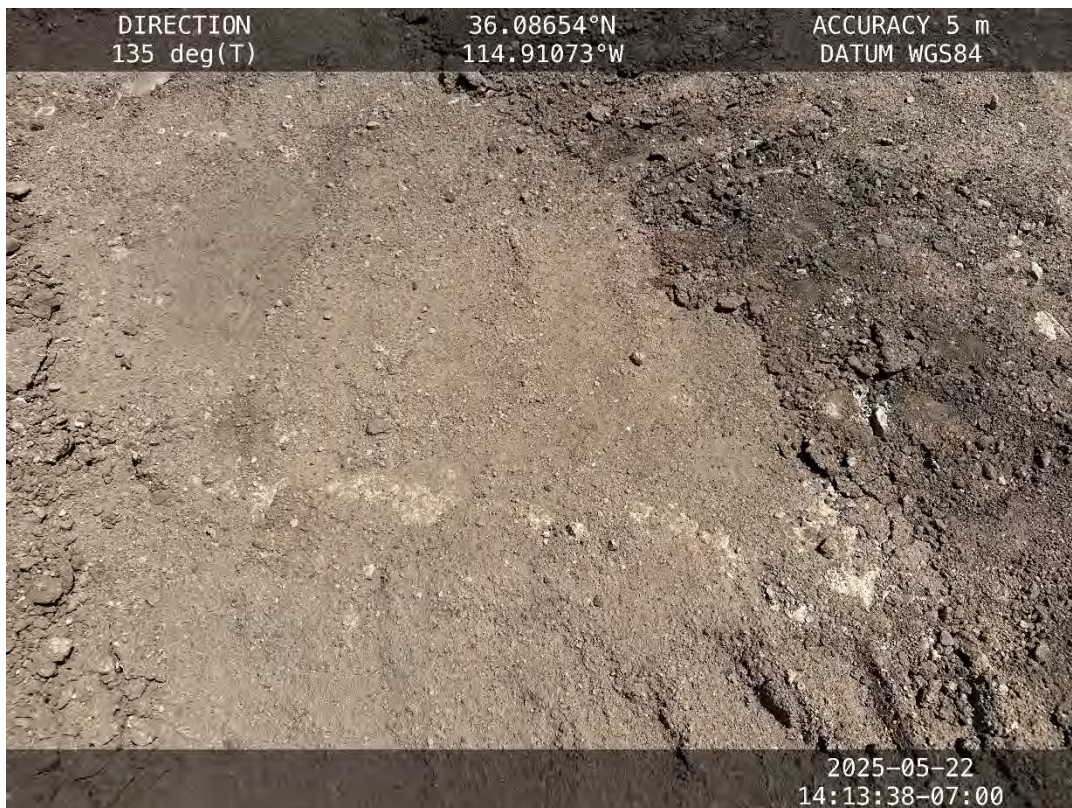
Location #2 – Concrete pad

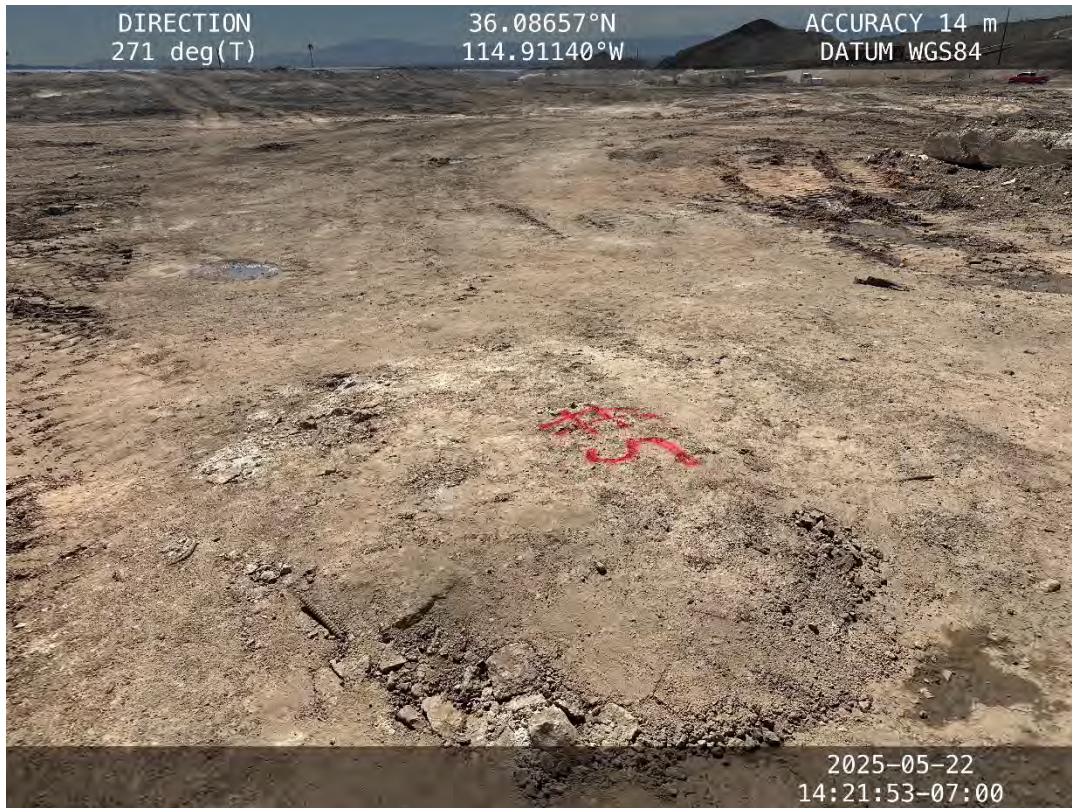
Location # 5 – Concrete pad

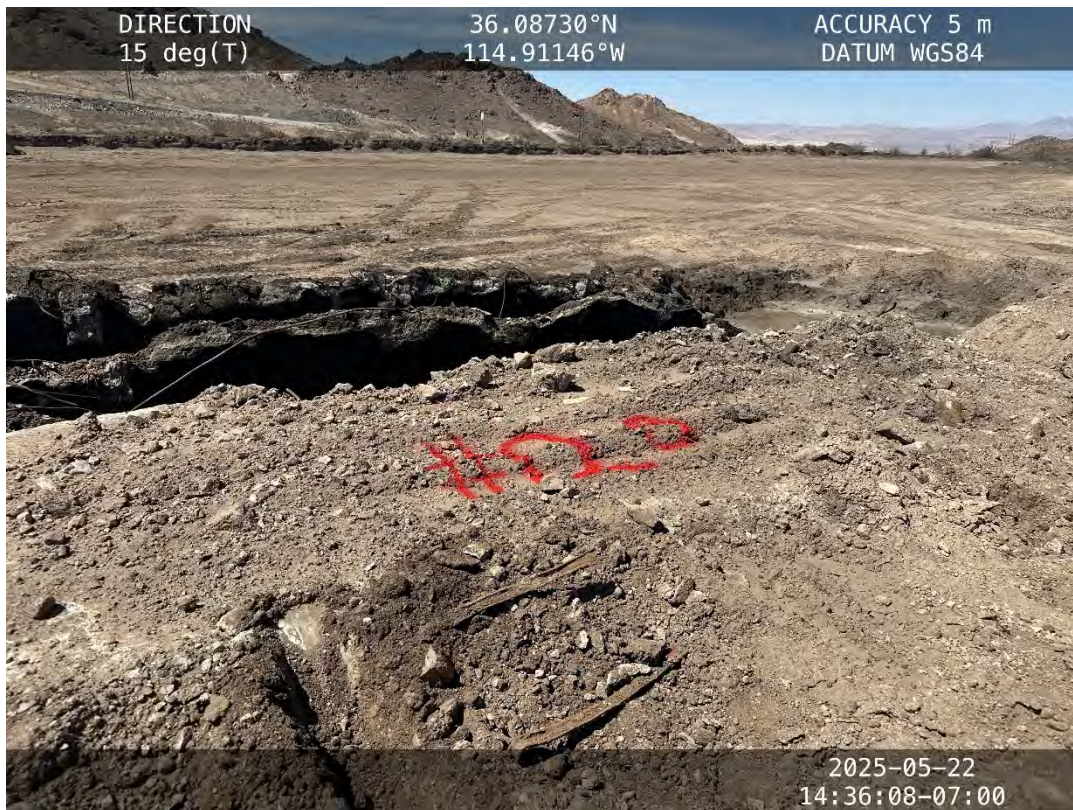
Location #12 – Concrete wall (east end)

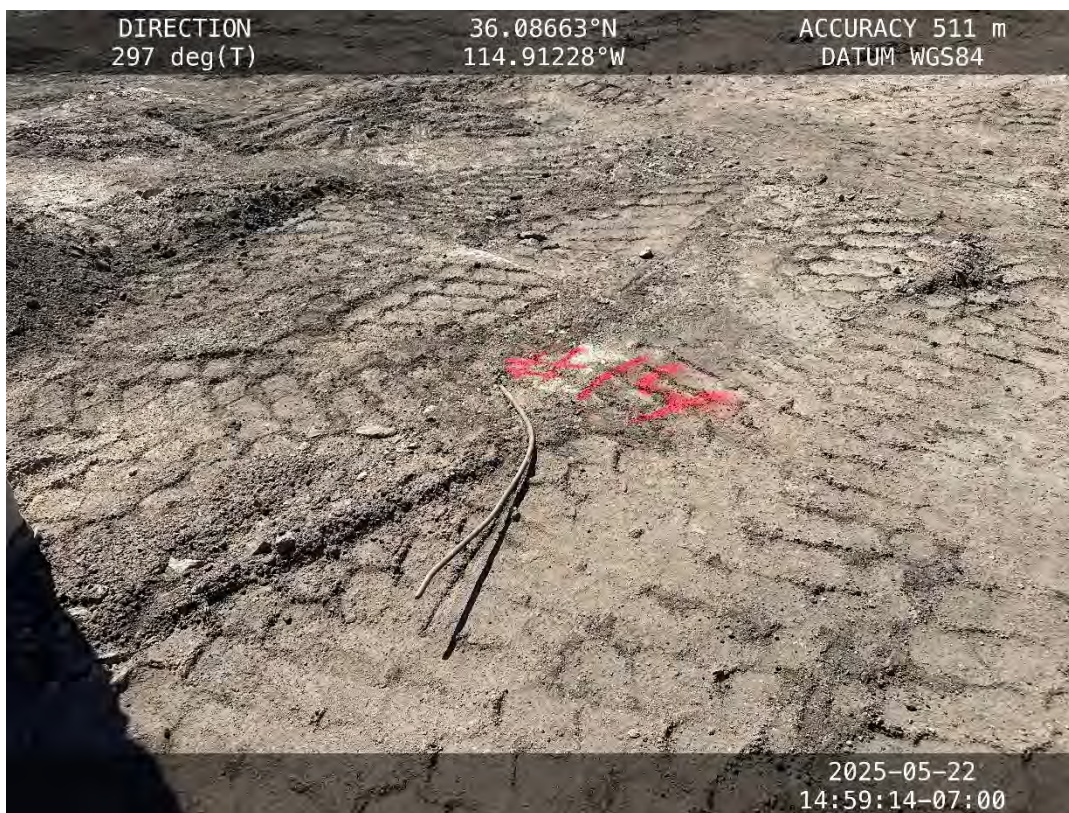
Location #14 – Concrete pad

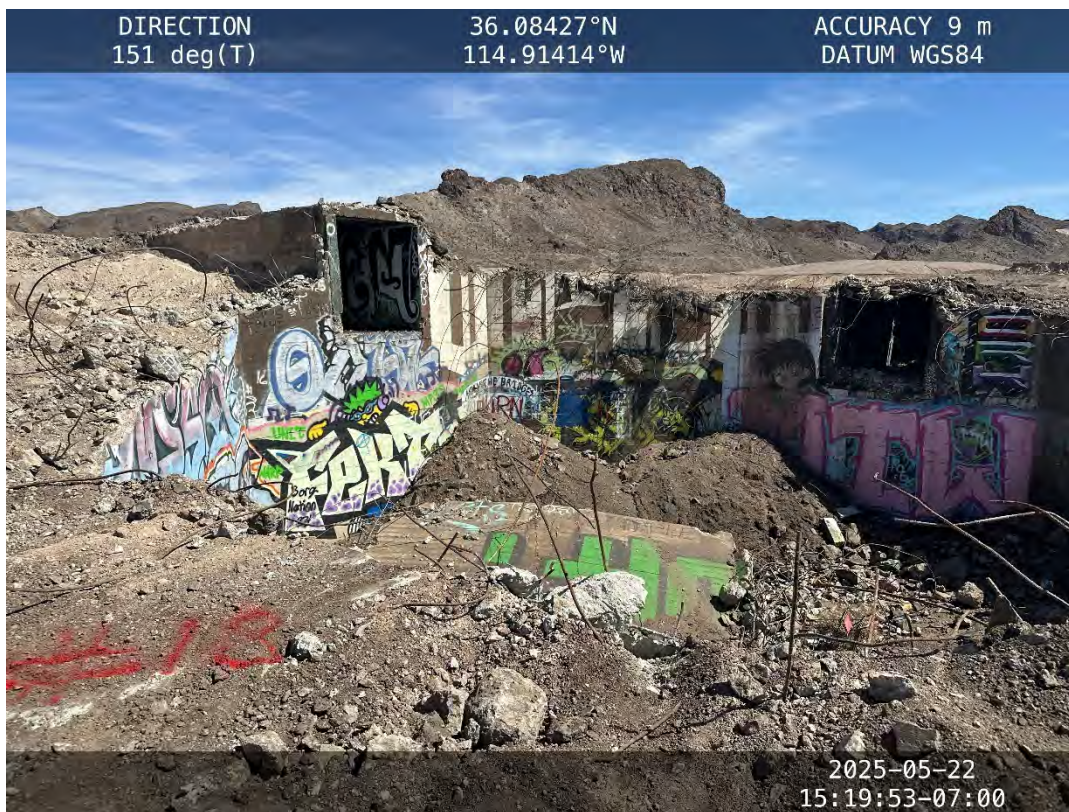
Location #18 – Western octagonal sump structure

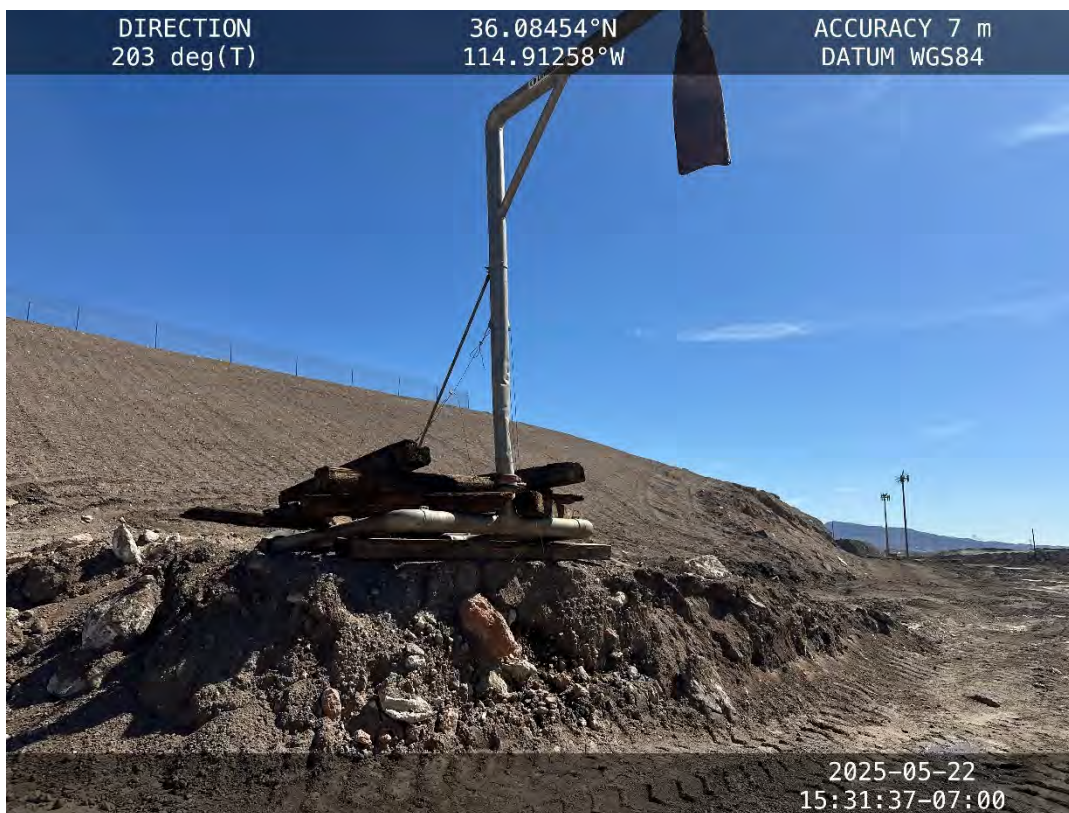
Location #19 – Slope containing construction water pond and J-stand

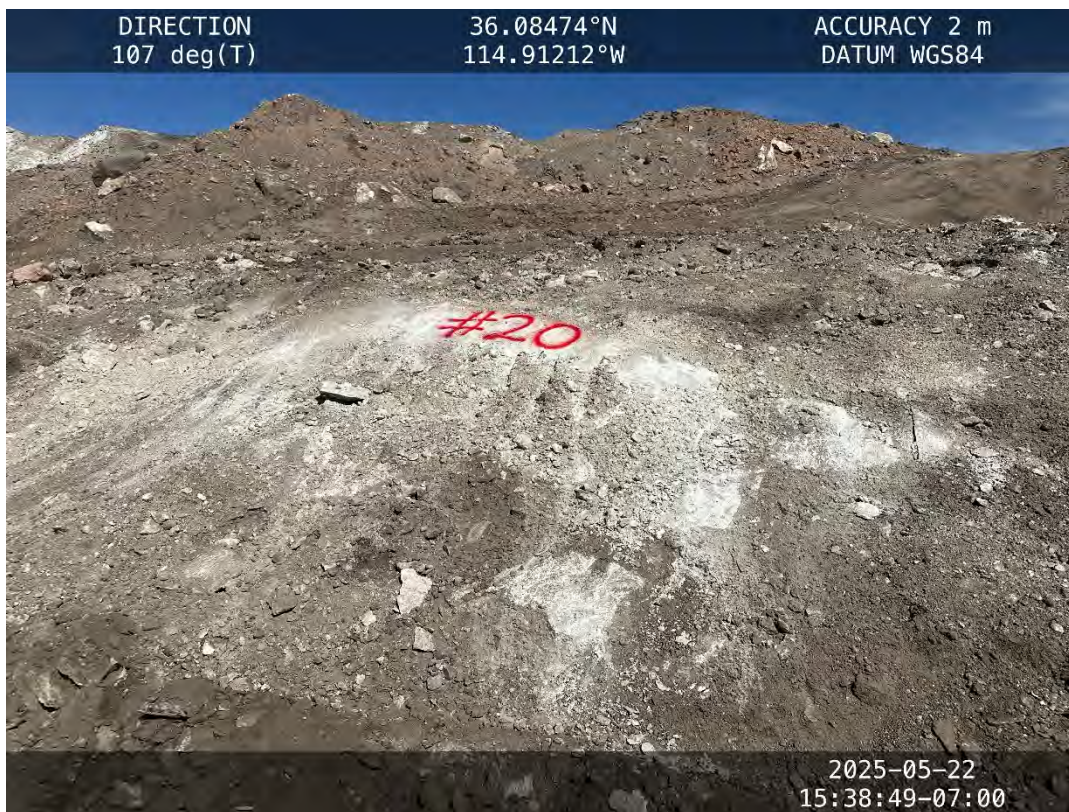
Location #20 – Hard gypsum bedrock

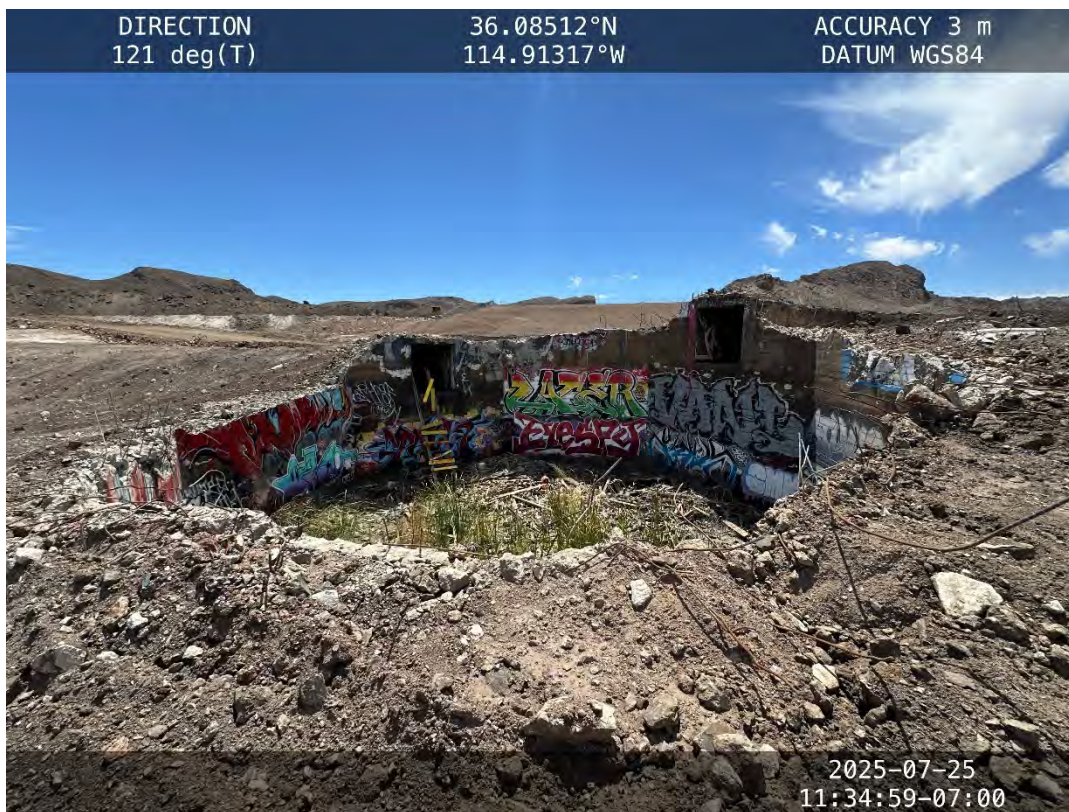
Location #22 – Western octagonal sump structure

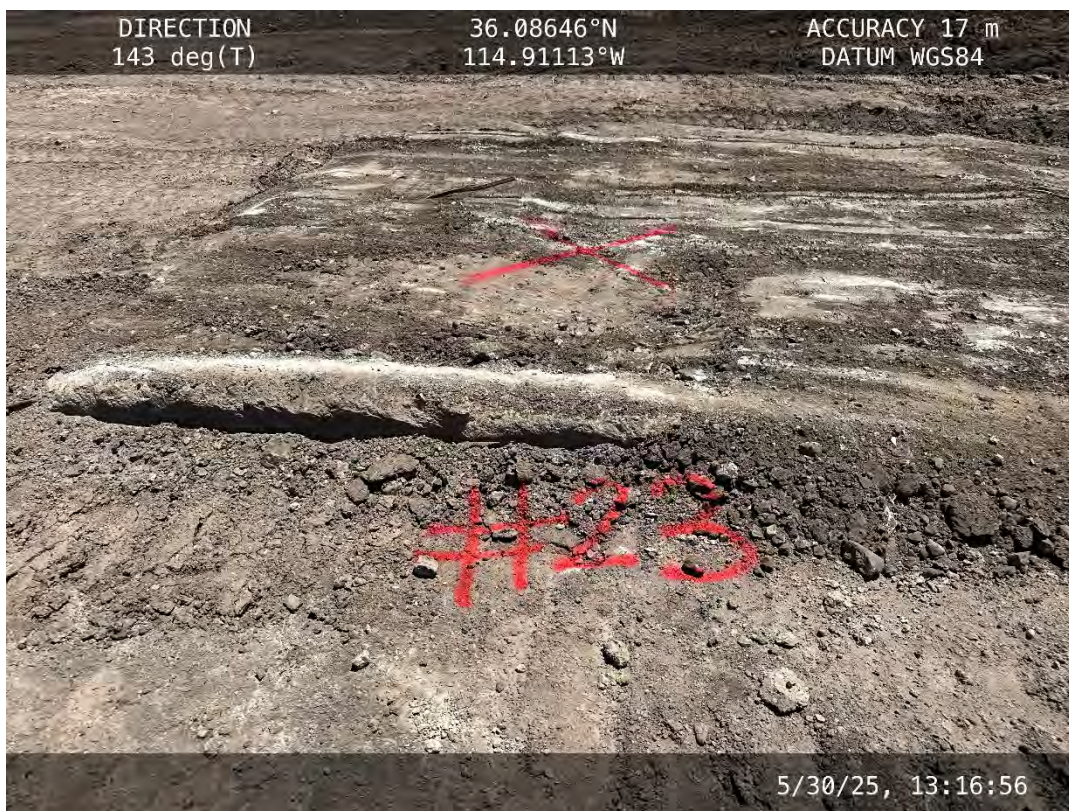
Location #23 – Concrete pad

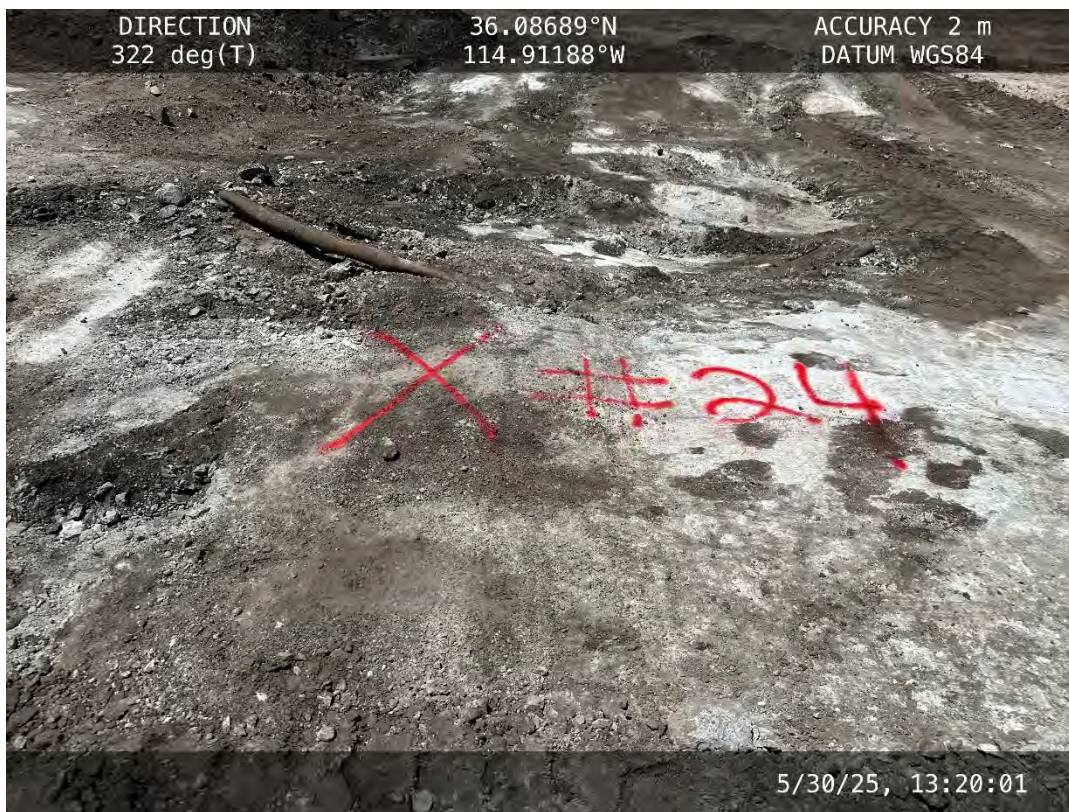
Location #24 – Concrete pad

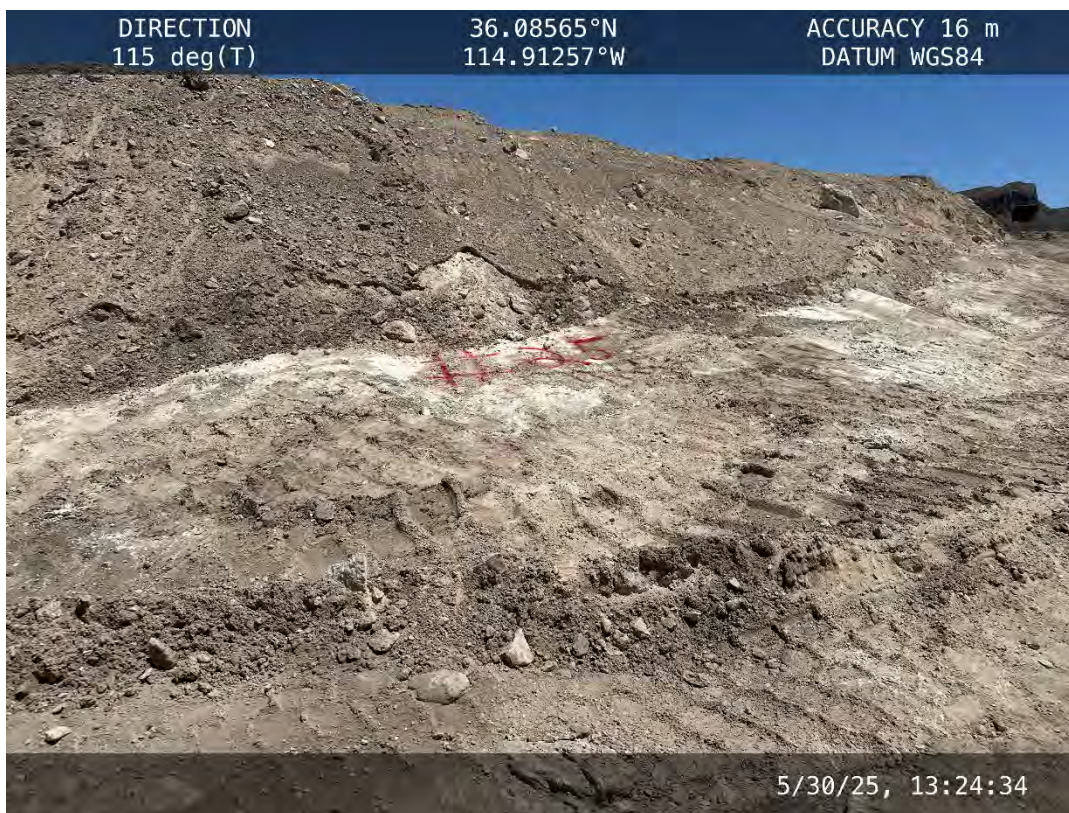
Location #25 – Hard bedrock and concrete

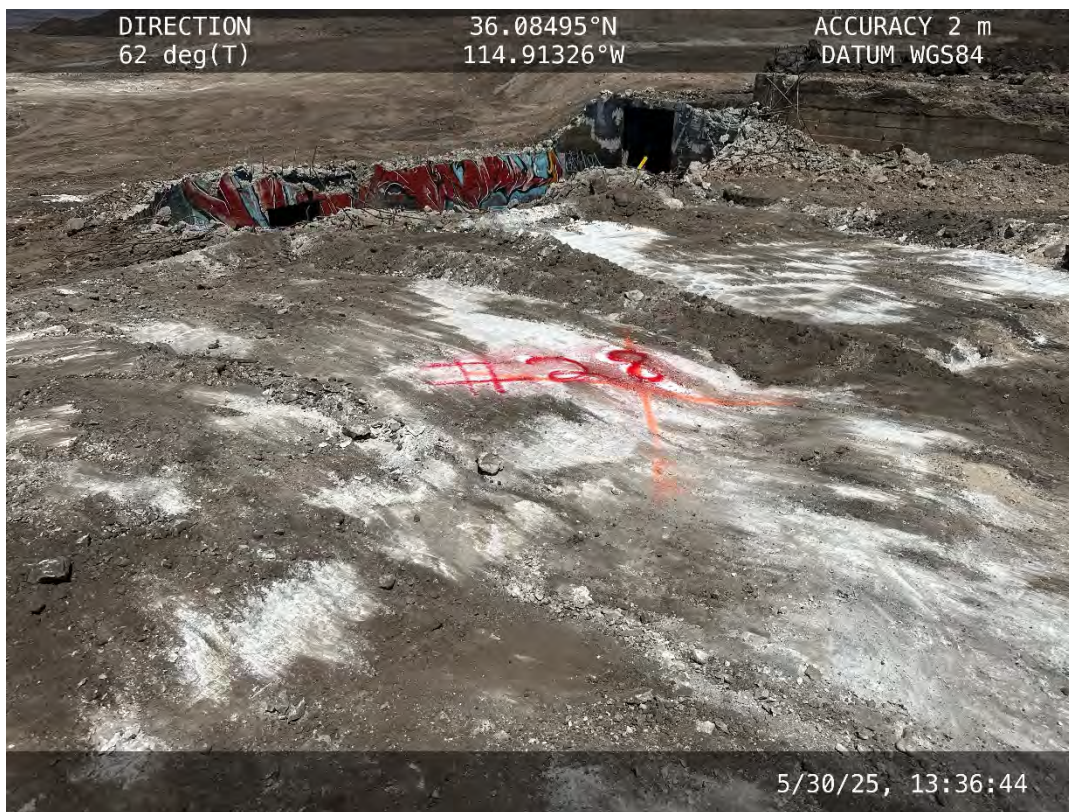
Location #28 – Concrete pad
