**Closure Unit 4 Work Completion Report, Revision 1**  
Three Kids Mine  
Henderson, Nevada

Project No. 23-01-200

Re: **Closure Unit 4 Work Completion Report, Revision 1**  
Three Kids Mine, Henderson, Nevada

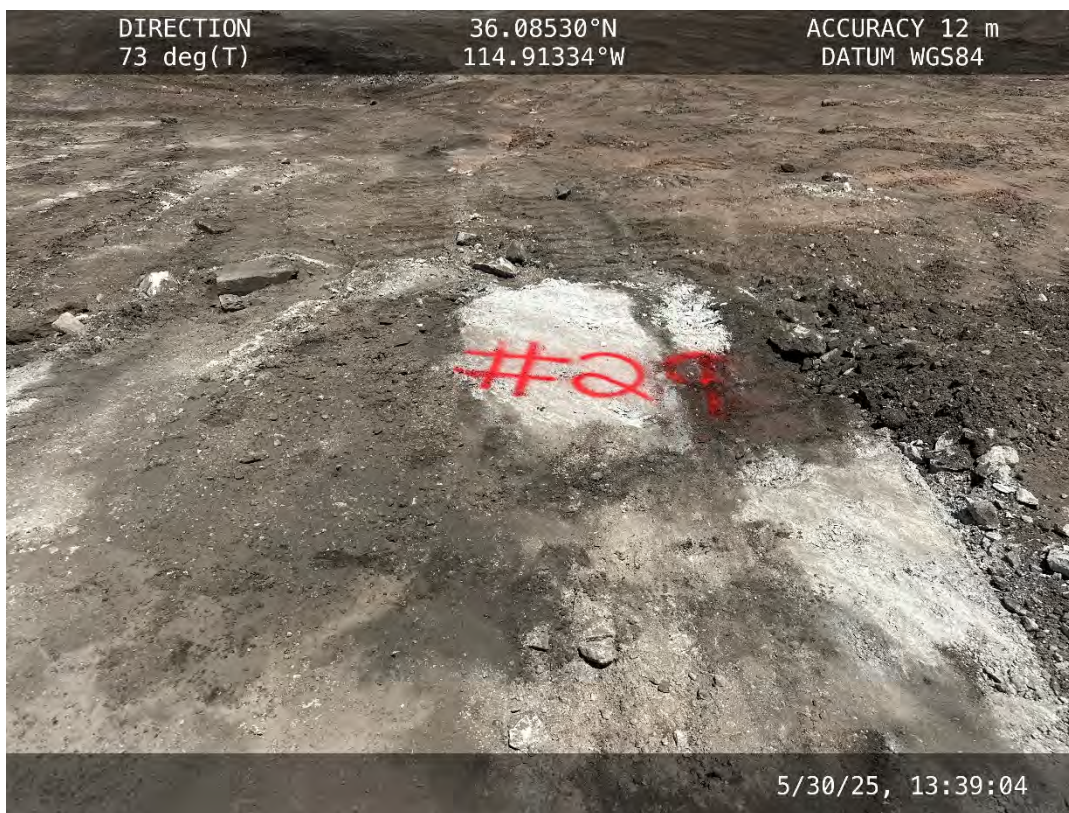
Location #29 – Concrete and hard bedrock

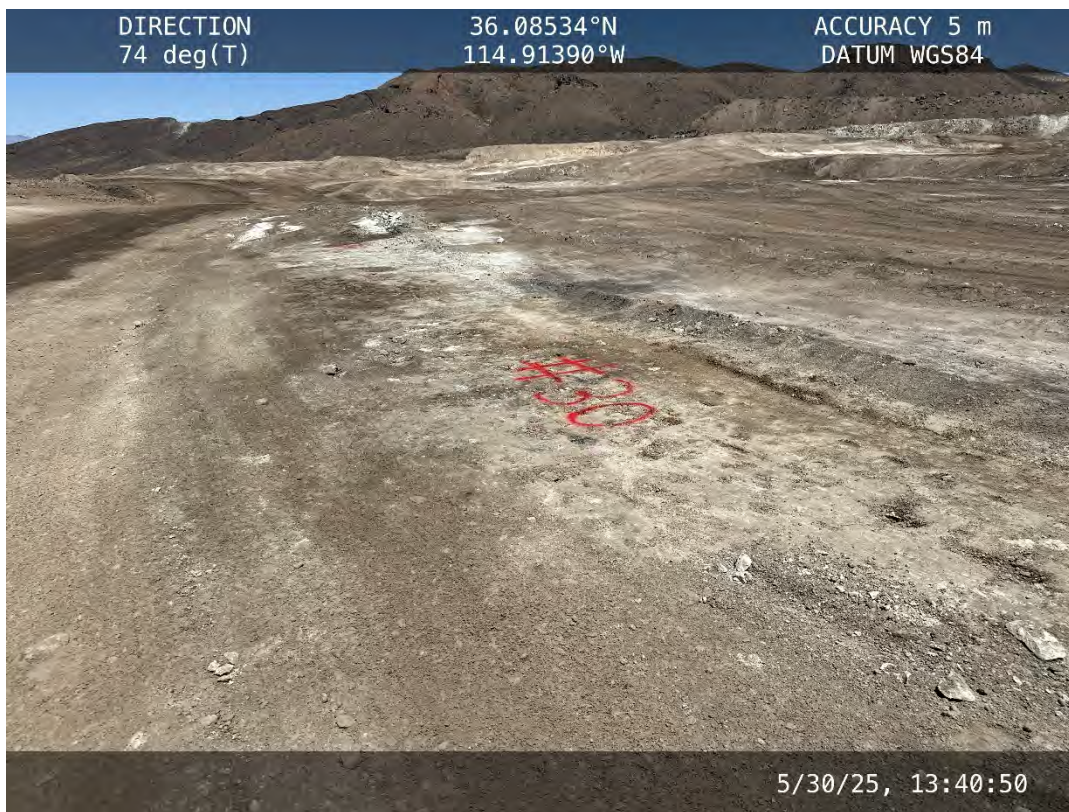
Location #30 – Concrete pad

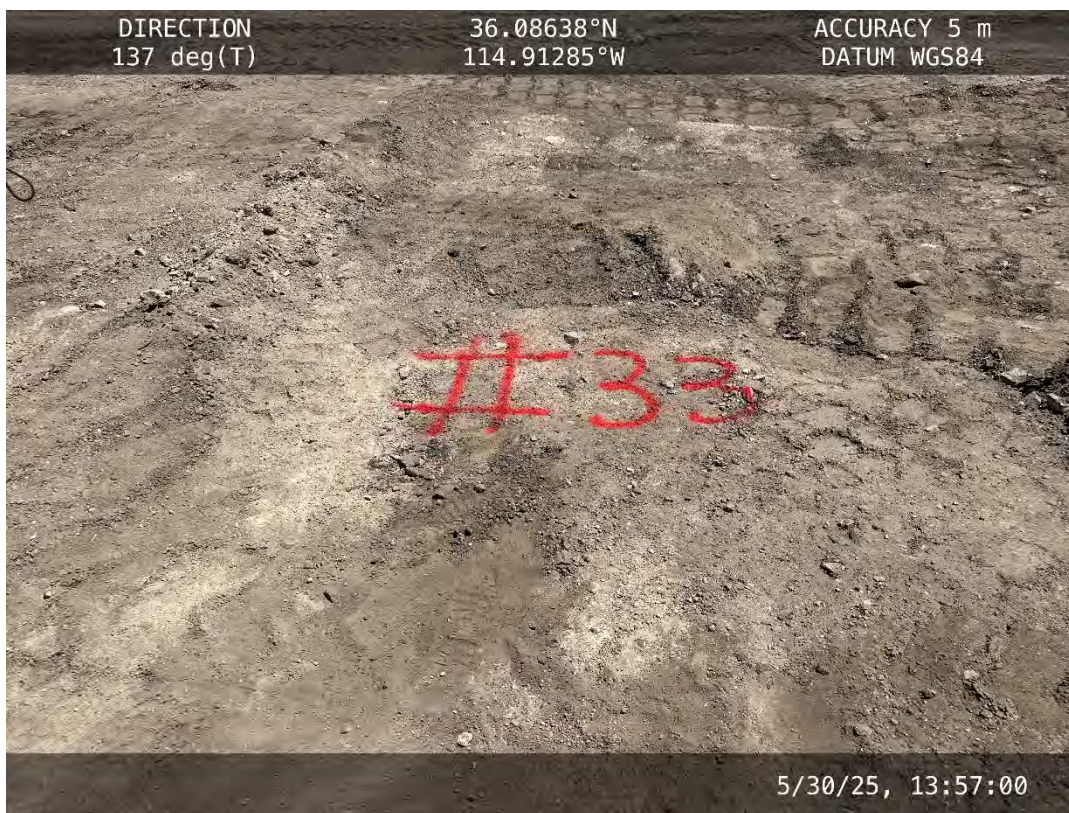
Location #33 – Concrete pad
