**Closure Unit 4 Work Completion Report, Revision 1**  
Three Kids Mine  
Henderson, Nevada

Project No. 23-01-200

Re: **Closure Unit 4 Work Completion Report, Revision 1**  
Three Kids Mine, Henderson, Nevada

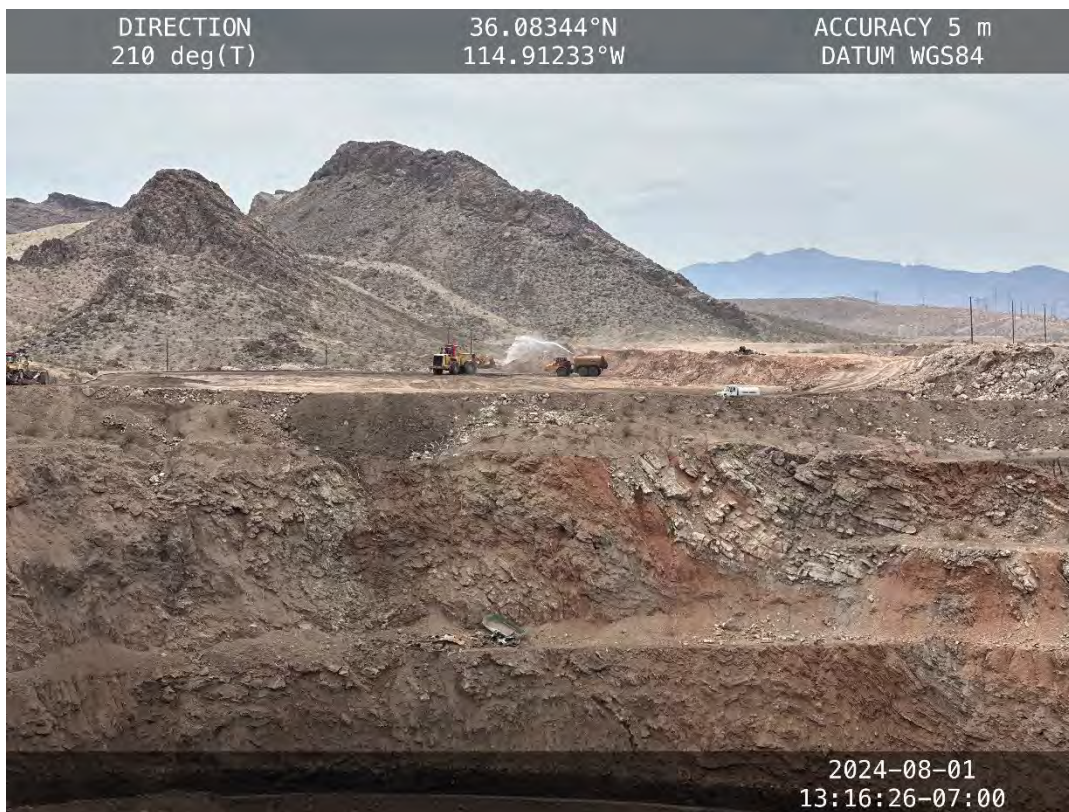
**Tailings Stockpile area – August 1, 2024**

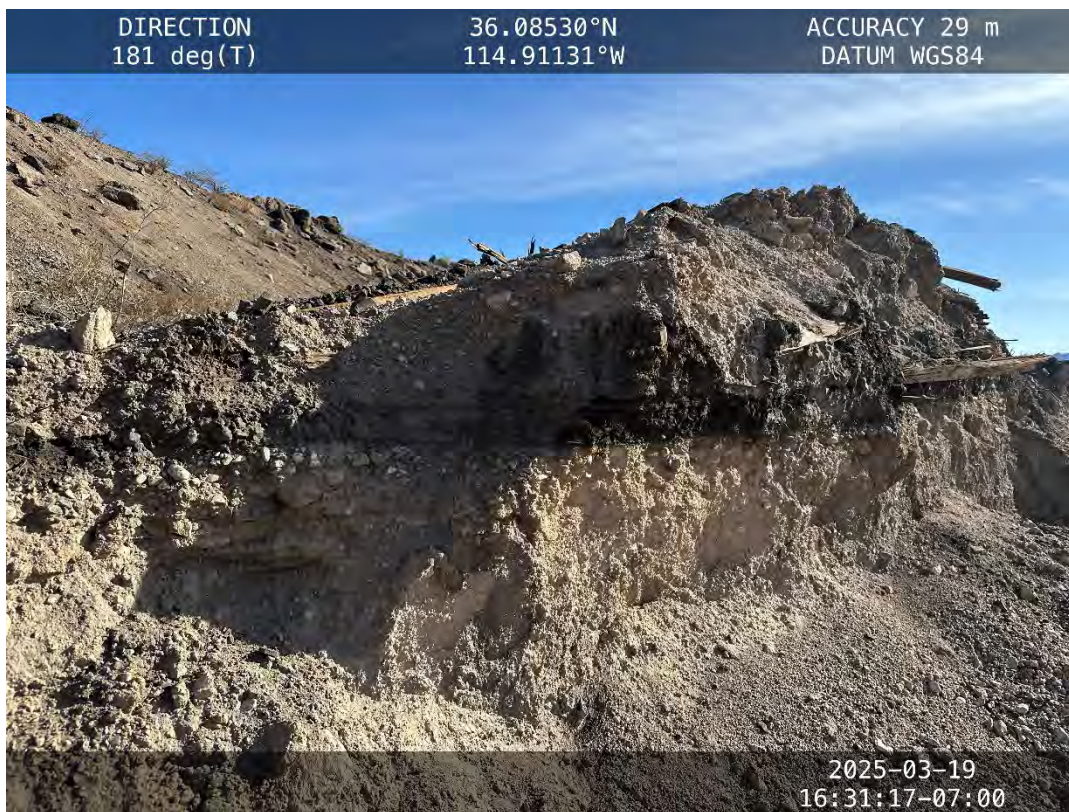
Tailings from Mill Site southeast of flotation cells – March 19, 2025

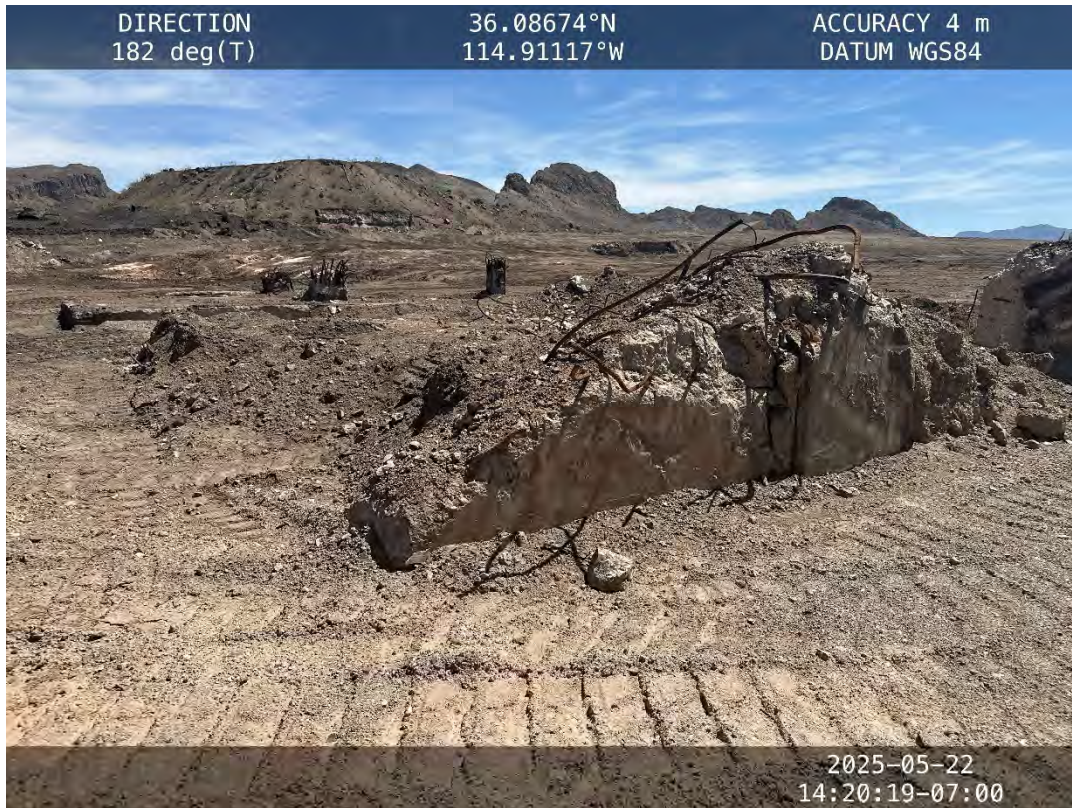
Location #3 – Concrete block

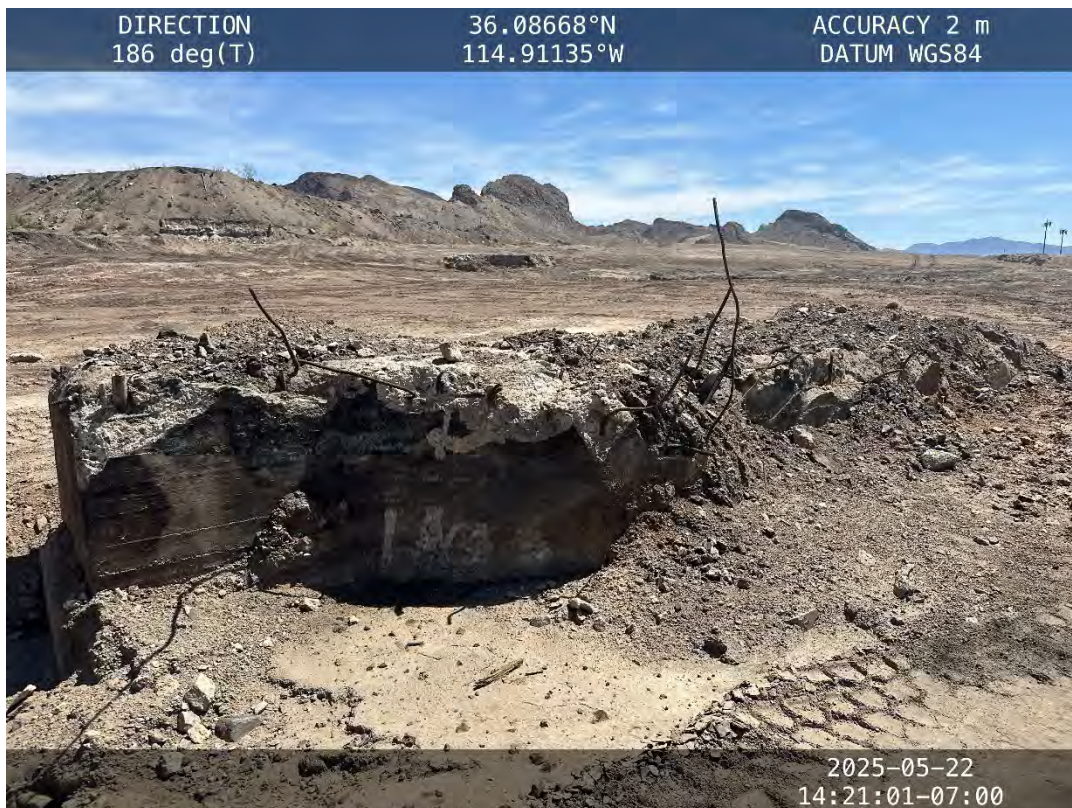
Location #4 – Concrete block

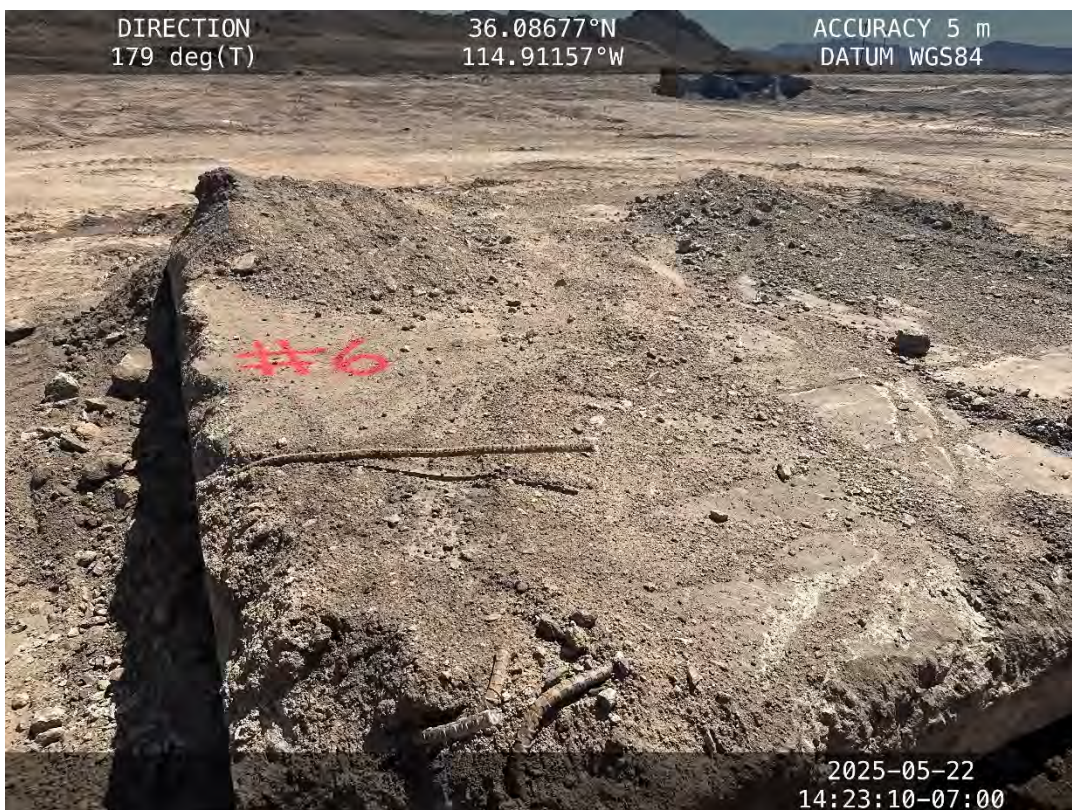
Location # 6 – Concrete block

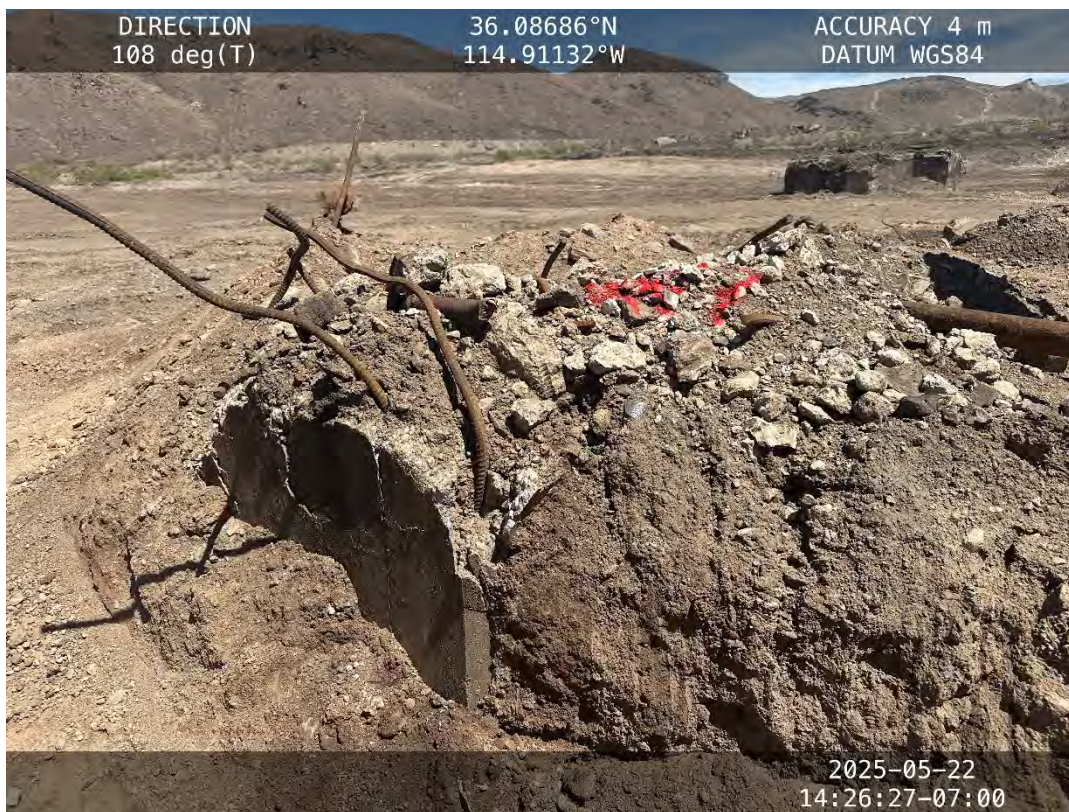
Location #7 – Concrete block

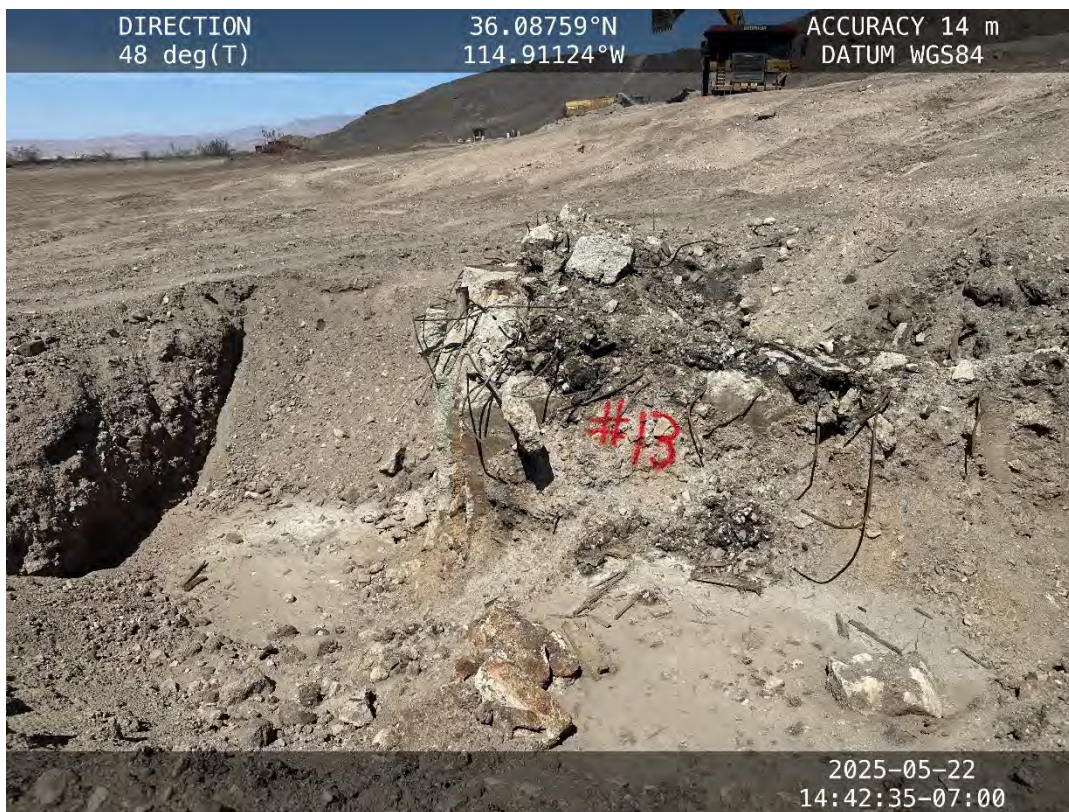
Location #13 – Concrete block

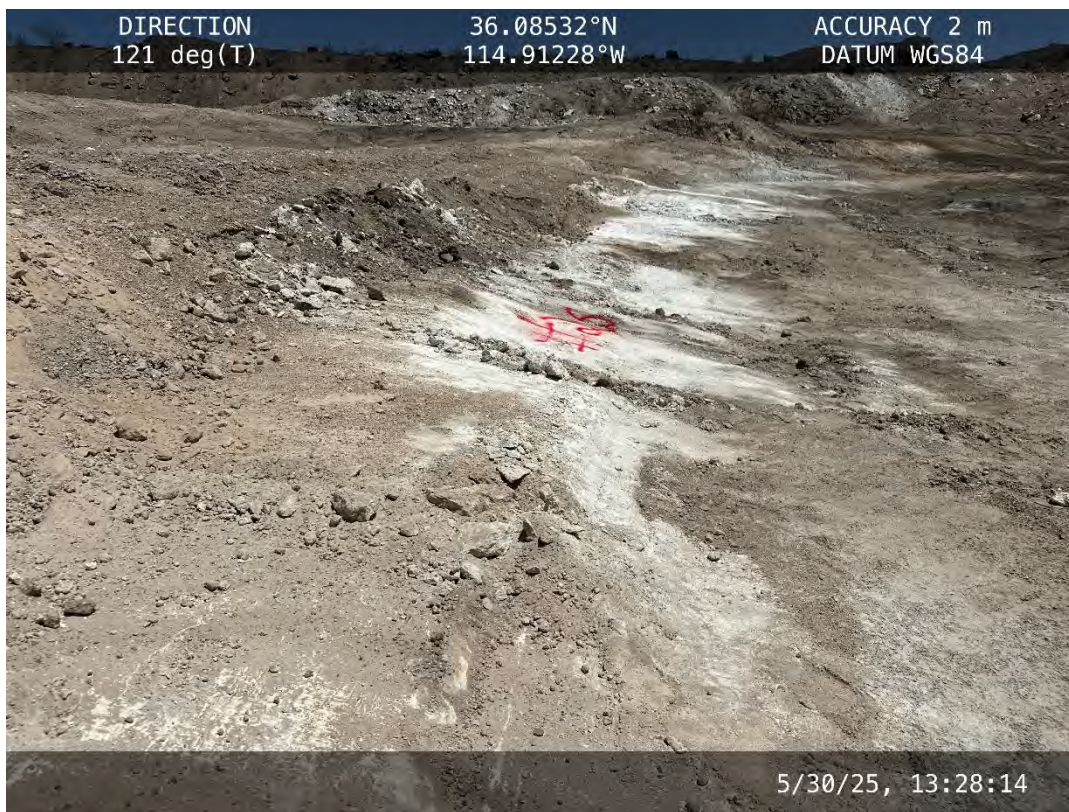
Location #26 – Hard bedrock

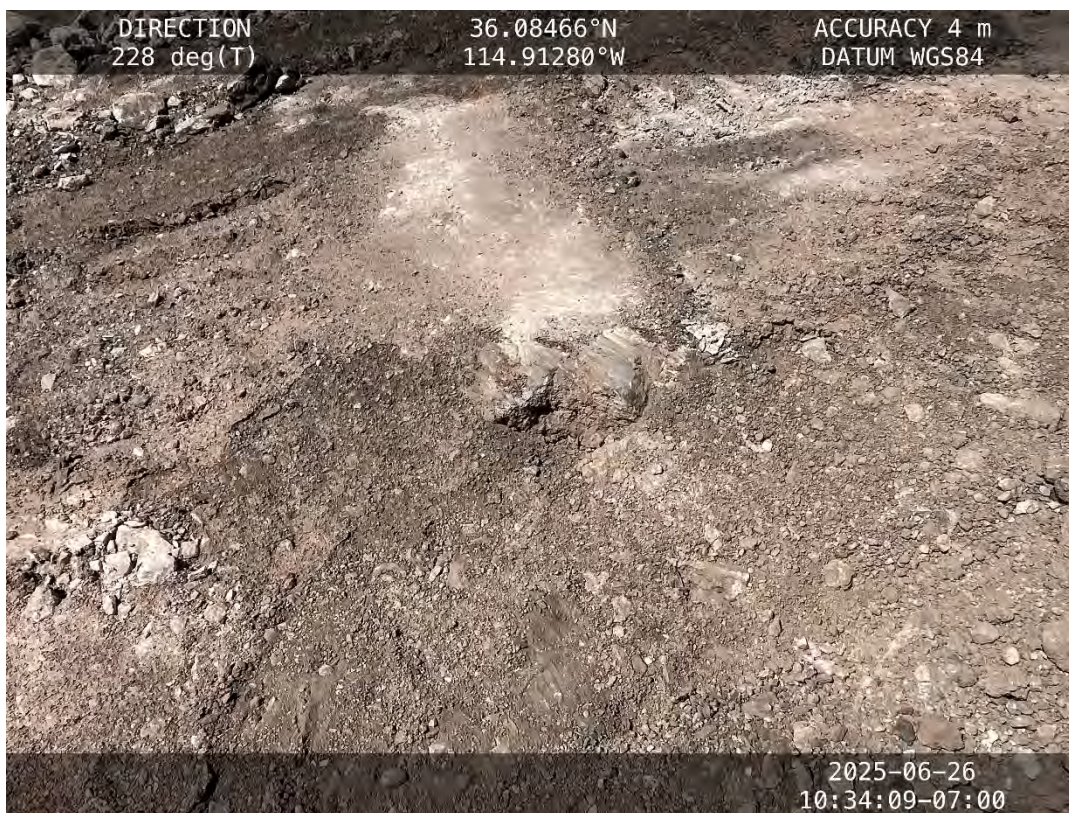
Location #27 – Hard bedrock

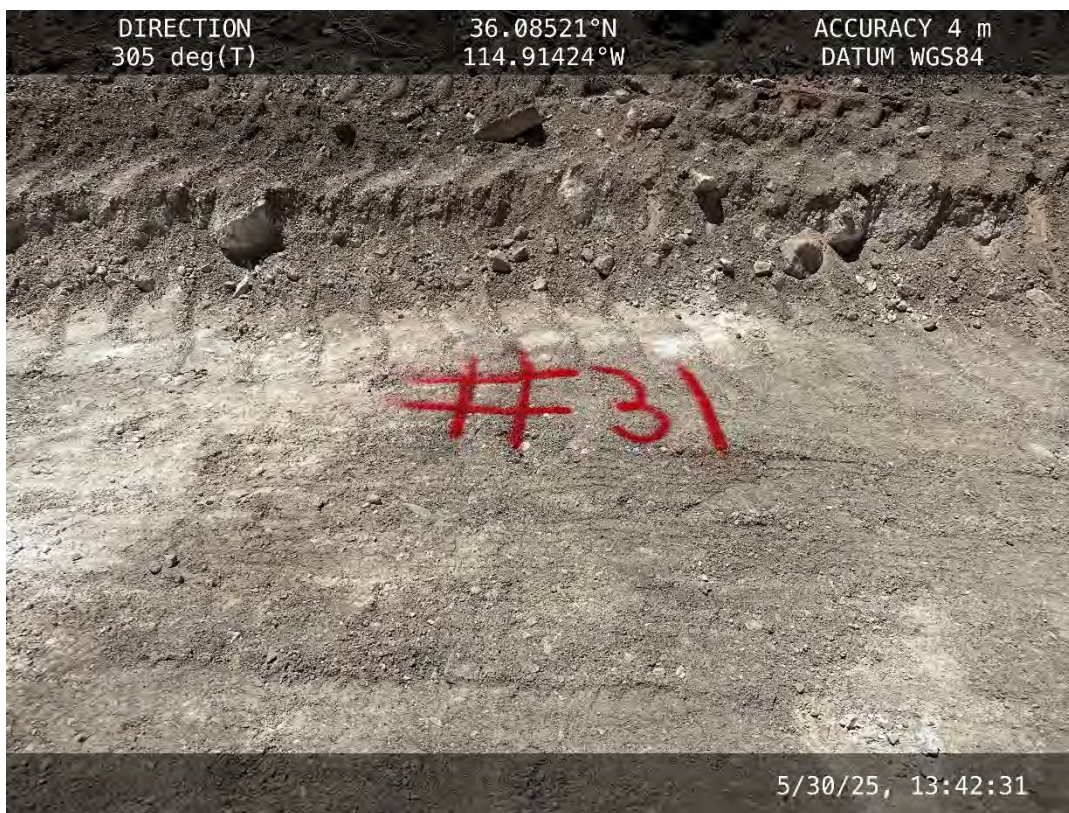
Location #31 – Hard bedrock

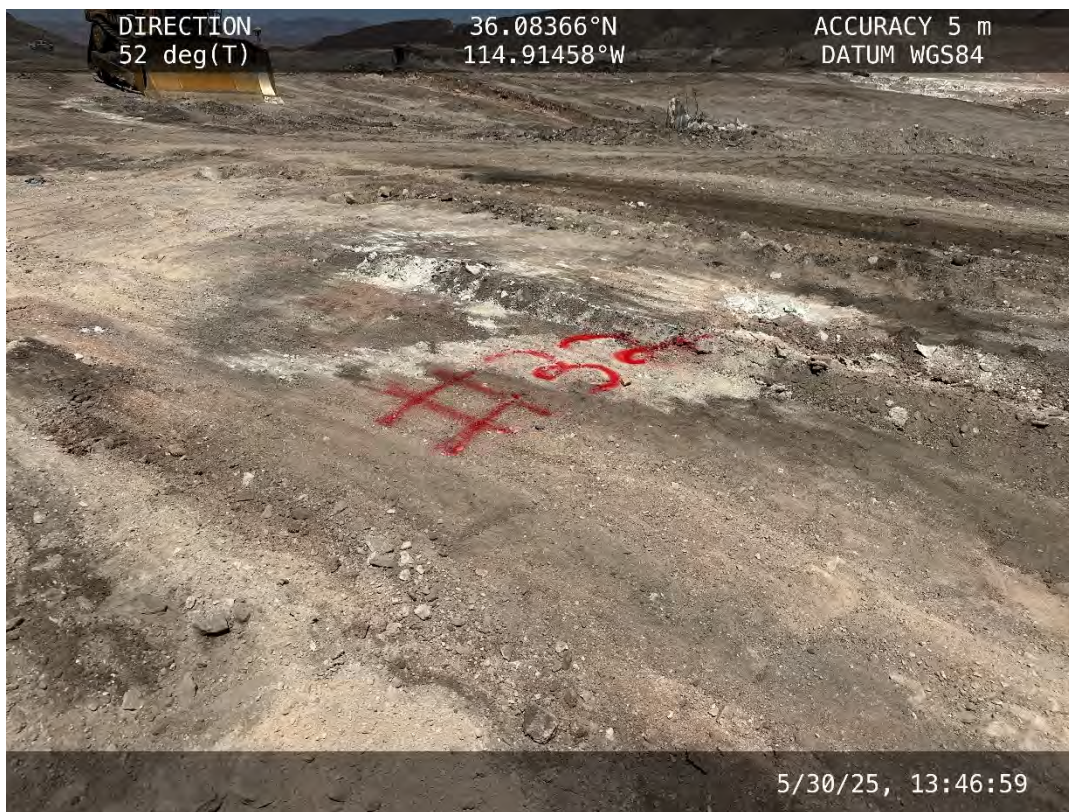
Location #32 – Hard bedrock
